ENVIRONMENTAL NOISE AUDIT
GRANTS ROAD SAND QUARRY
SOMERSBY
NOVEMBER 2019

2019 Grants Road Sand

**HIGH PRIORITY GROUNDWATER DEPENDANT ECOSYSTEM
2019 ANNUAL MONITORING REPORT**

**LANDSCAPE REHABILITATION
&
BIODIVERSITY OFFSET AREA
2019 ANNUAL MONITORING REPORT
GRANTS ROAD
SAND QUARRY EXTENSION**

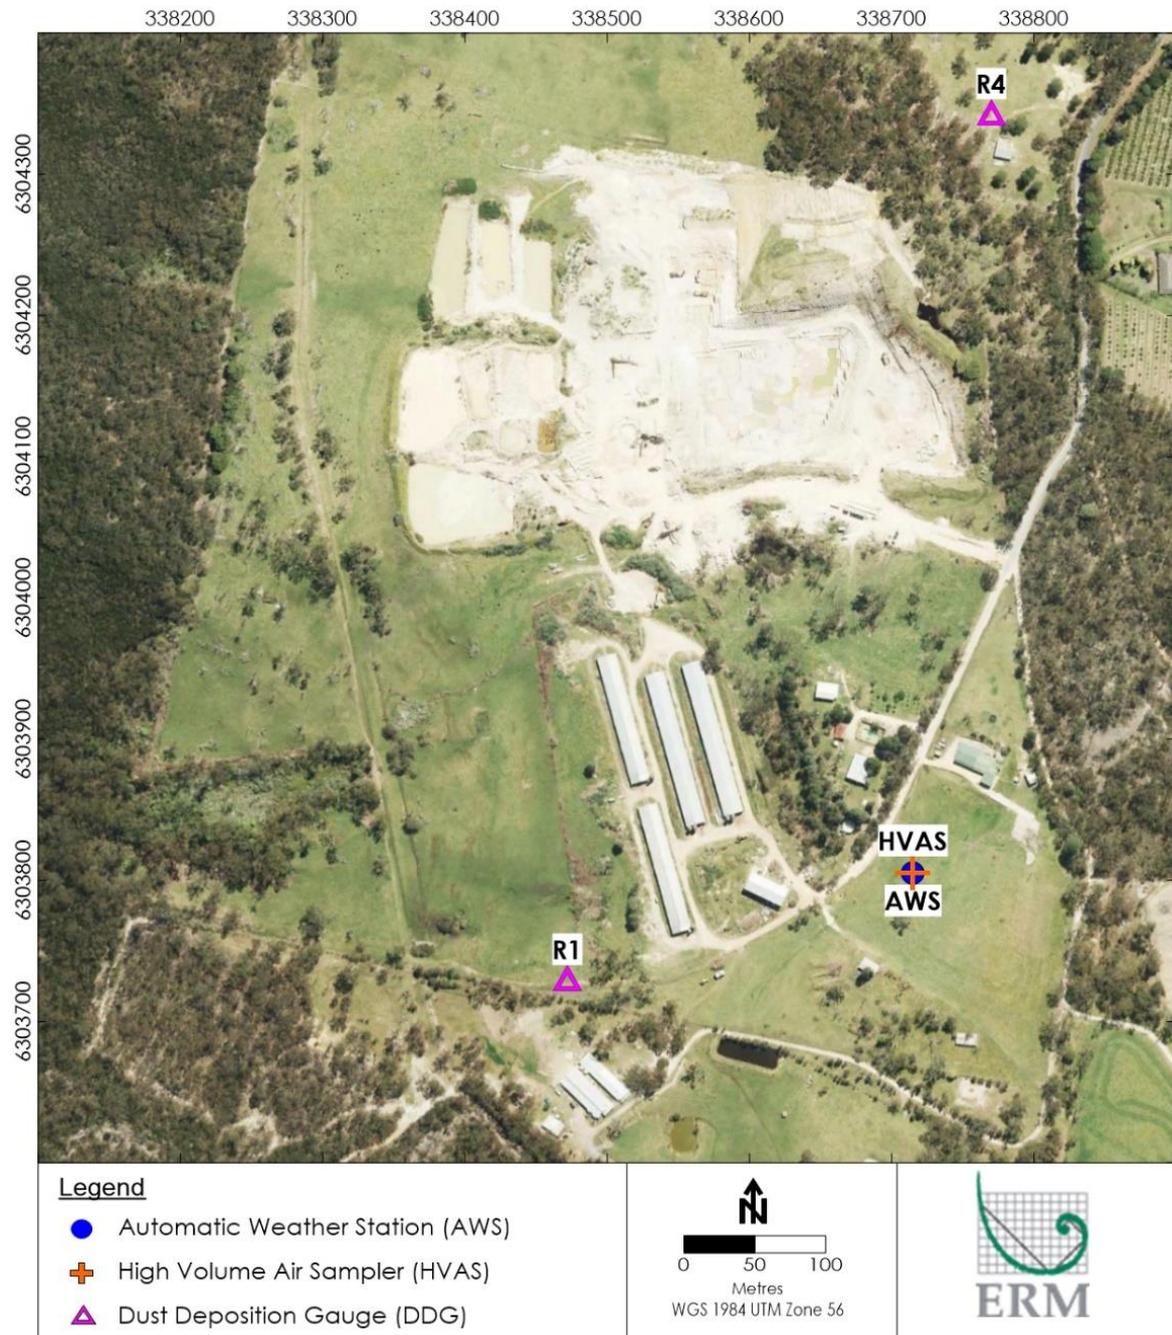
Figure 1: Monitoring Locations at Grants Road Quarry

The Grants Road Sand Quarry compliance monitoring locations are shown in **Figure 1**. Featured are the automatic weather station (AWS), the High Volume Air Sampler (HVAS) and two dust deposition gauges (R1 and R4).

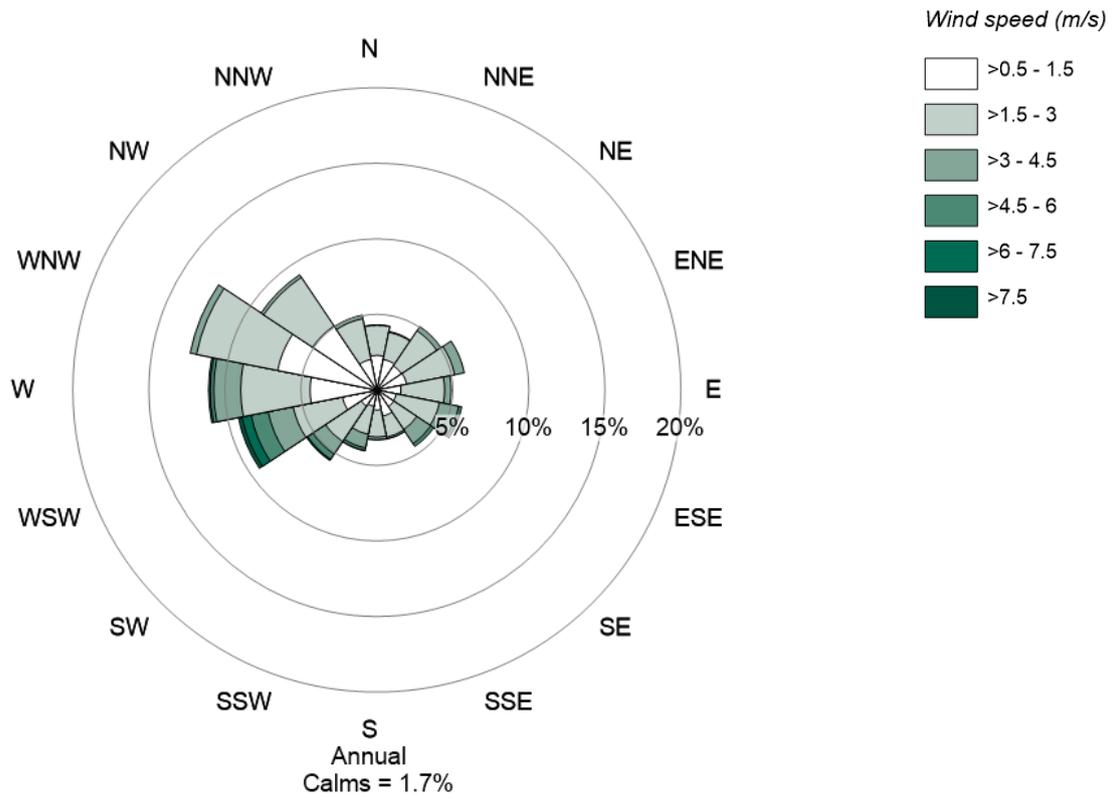
Figure 2: Grants Road Sand Wind Rose, 2019

A wind rose for the annual period 2019 is presented in **Figure 2**. The wind rose indicates that winds from the west are dominant. The average wind speed for the period was 2.0 m/s and the percentage occurrence of calm wind conditions (less than or equal to 0.5 m/s) was 1.7%.

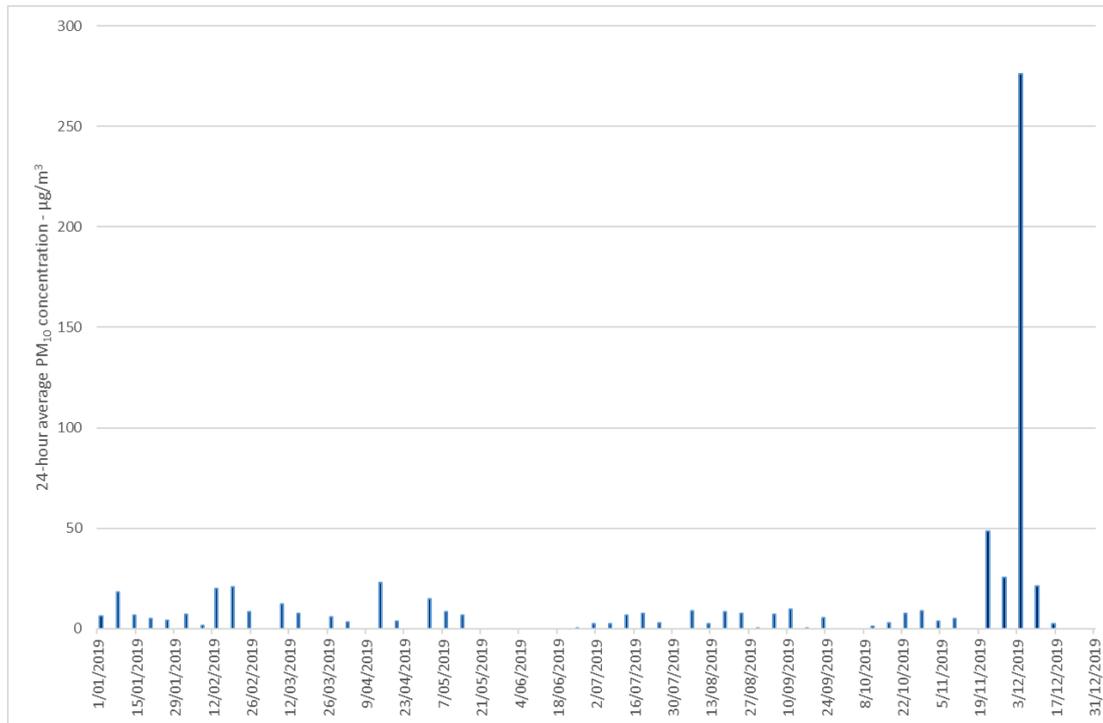
Figure 6: HVAS monitoring results for PM₁₀, 2019

The predicted annual average PM₁₀ concentration in the AQA was approximately 30 µg/m³ at the HVAS location, however an annual average concentration of 14.6 µg/m³ was measured in 2019. This is consistent with the 24-hour results, where the actual concentration has been established to constitute 50% or less than the predicted concentration at the same location. Given the results of the data during the monitoring period, currently no action is required to control environmental performance. Rather it is recommended that current mitigation processes are sustained.

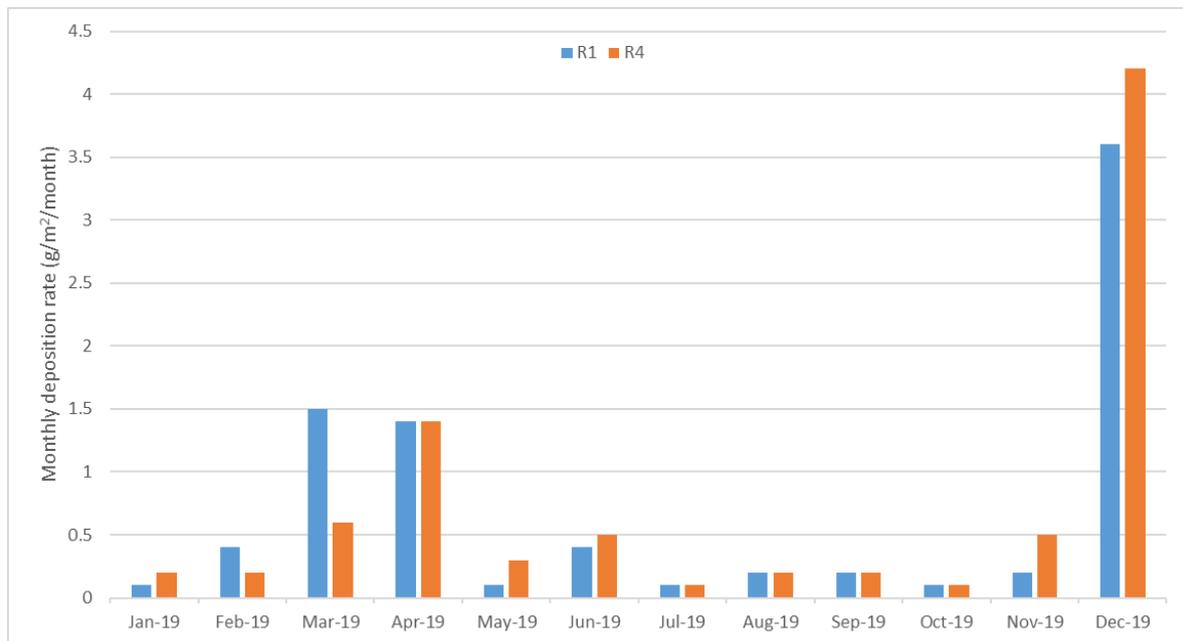
Figure 7: Dust deposition monitoring results for 2019

Given the results of the data during the monitoring period, currently no action is required to control environmental performance. Rather, it is recommended that current mitigation processes are sustained.

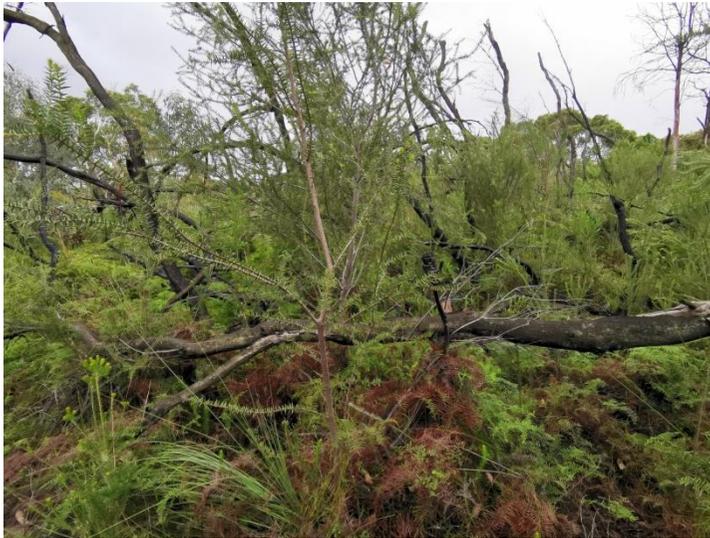
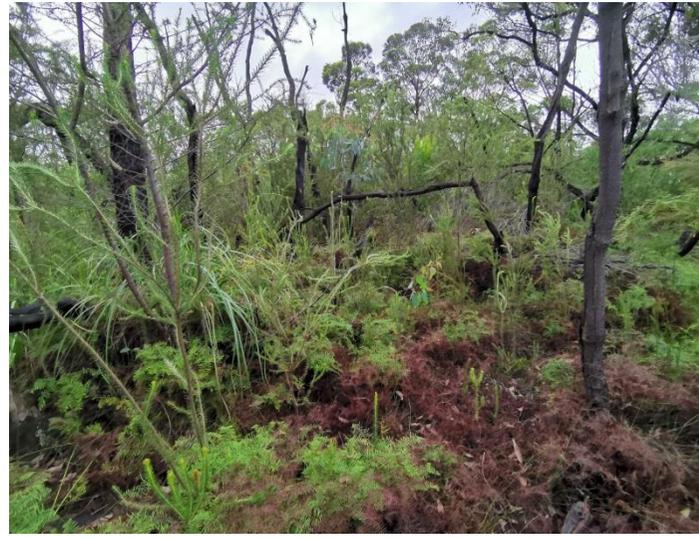
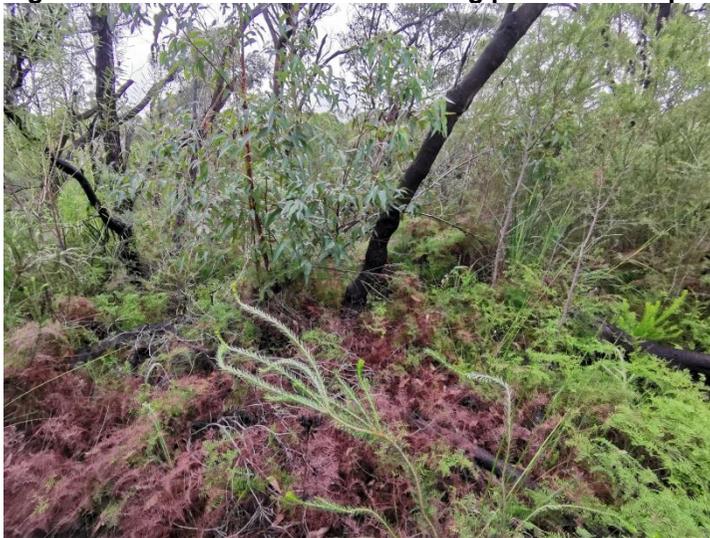
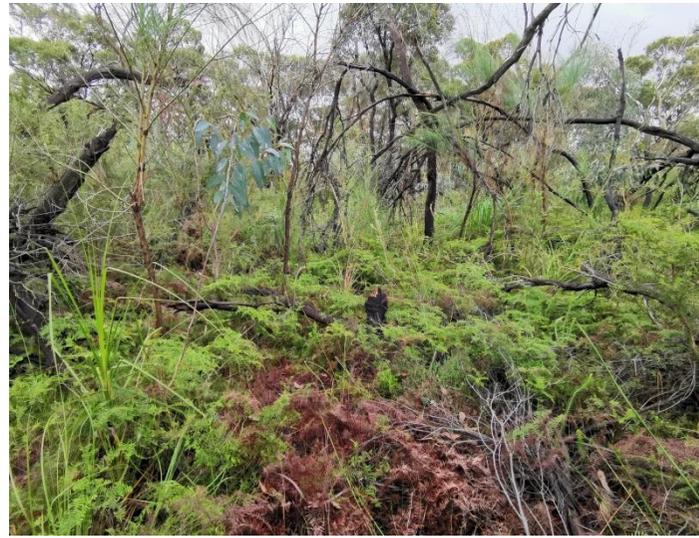
The sandstone hanging swamp plots recorded a decline in the indicator species cover by approximately 6 to 7 % for plots 1 and 3. This was due to browning of *Gleichenia microphylla* which is likely due to some self-shading and also drought conditions during the 2019 monitoring period. New growth on *Gleichenia microphylla* was observed and no complete dieback of plants within the plots was recorded.

Figure 2.1a – Plot 1 Photo-monitoring point north aspect

Figure 2.1b - Plot 1 Photo-monitoring point east aspect

Figure 2.1c - Plot 1 Photo-monitoring point south aspect

Figure 2.1d - Plot 1 Photo-monitoring point west aspect

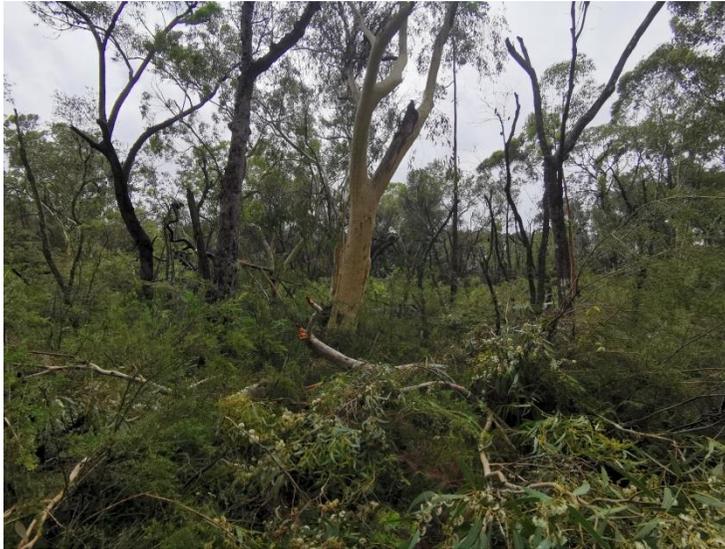
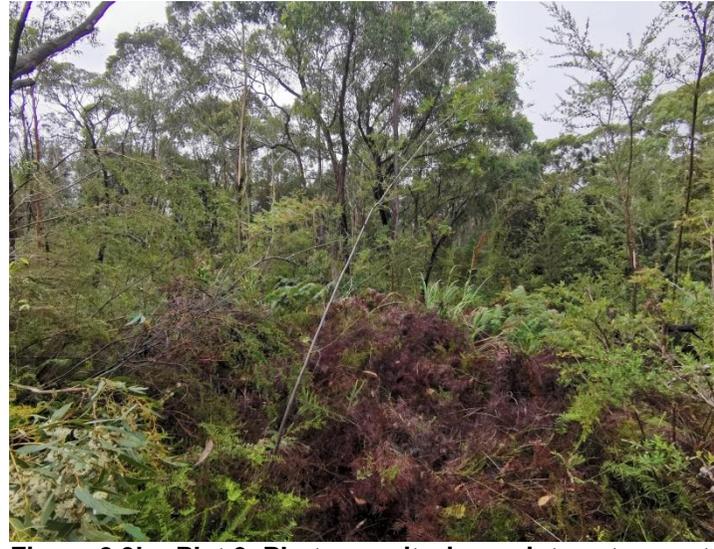
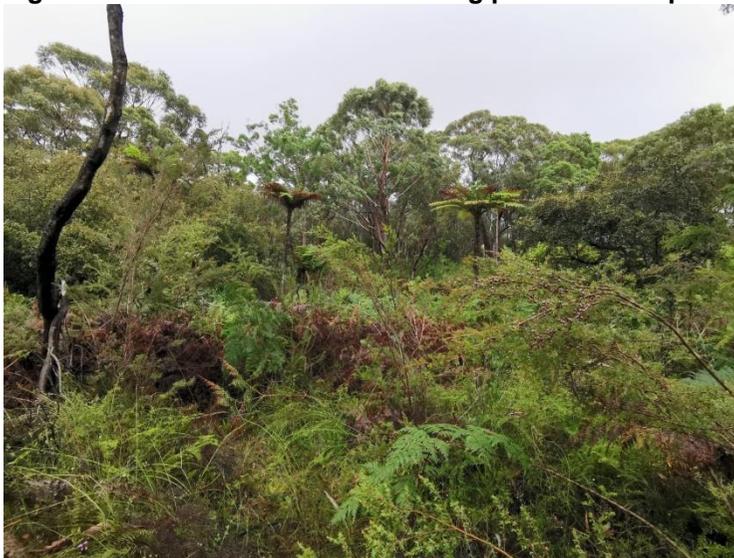
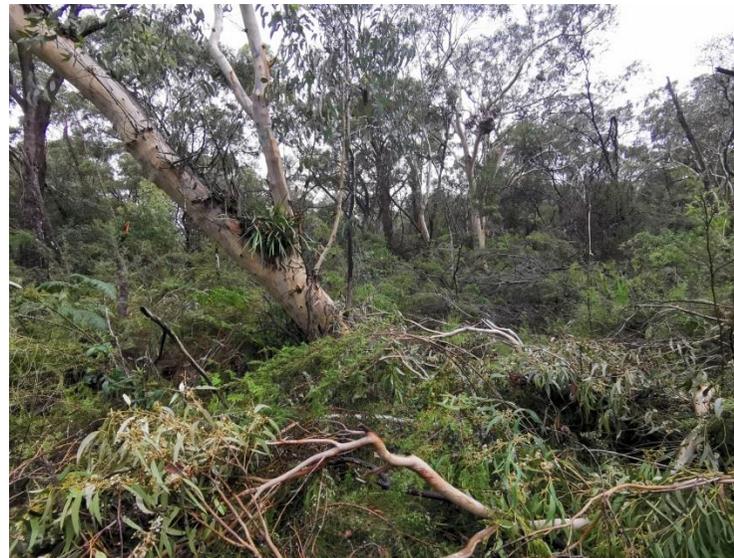
Figure 2.3a – Plot 3 Photo-monitoring point north aspect

Figure 2.3b - Plot 3 Photo-monitoring point east aspect

Figure 2.3c - Plot 3 Photo-monitoring point south aspect

Figure 2.3d - Plot 3 Photo-monitoring point west aspect

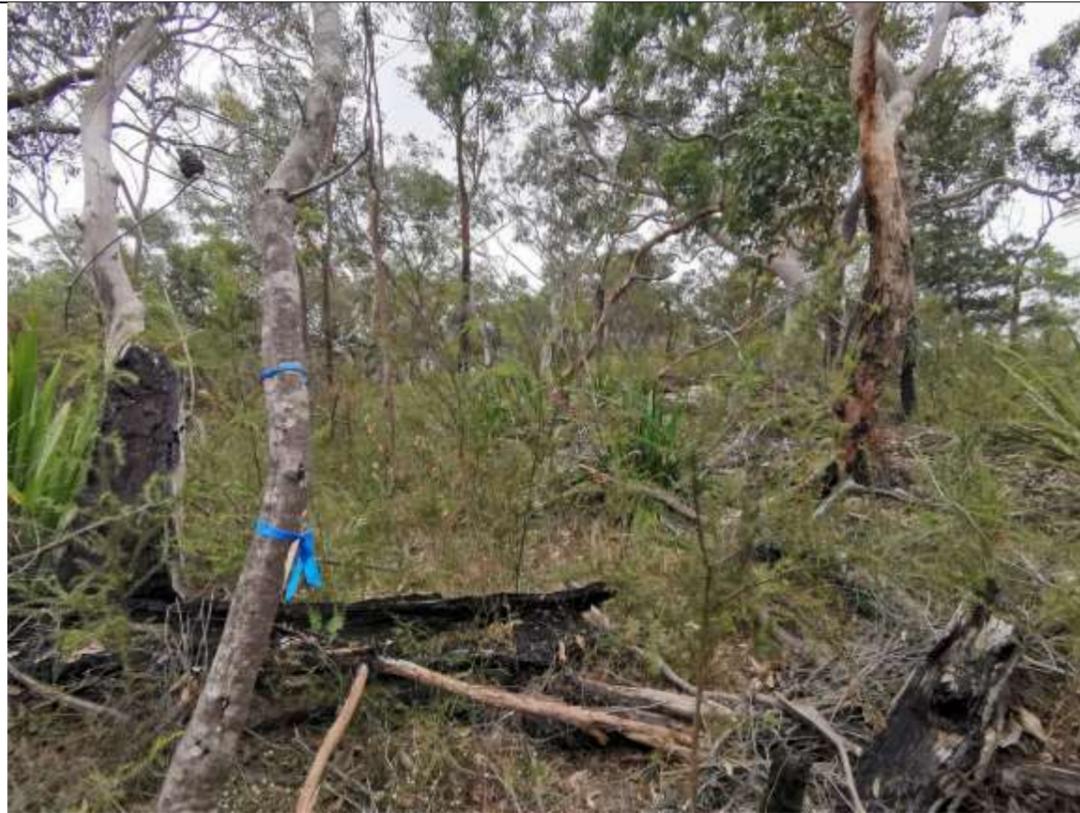
Figure 2.2a – Sub-population 3 photo monitoring point north aspect

The vegetation adjoining the eastern edge of Subpopulation 3 had been disturbed within approximately 3 to 4m of the site boundary fence when checked on 14 February 2020.

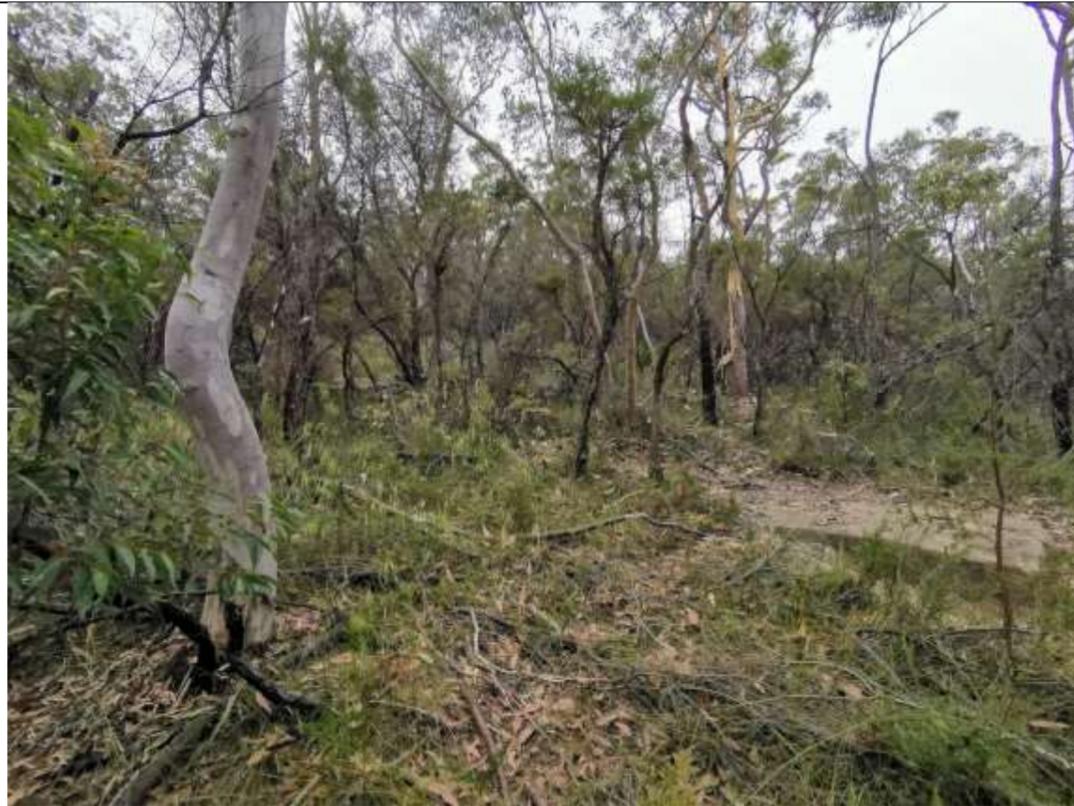
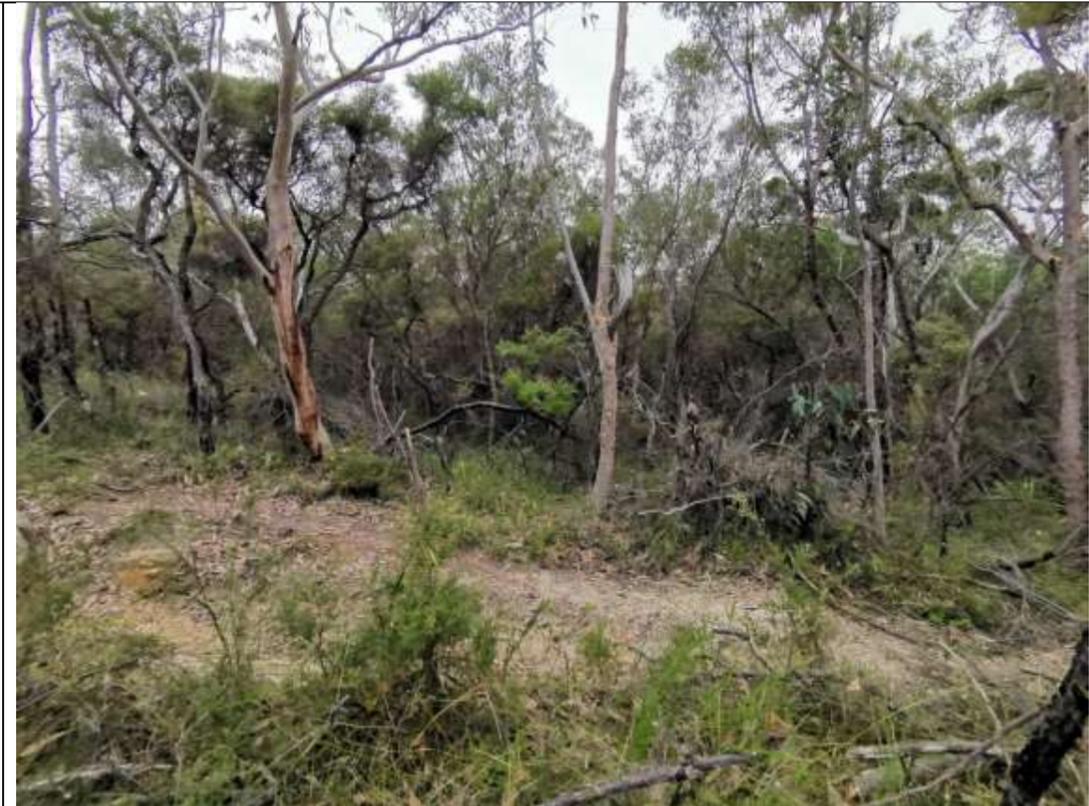
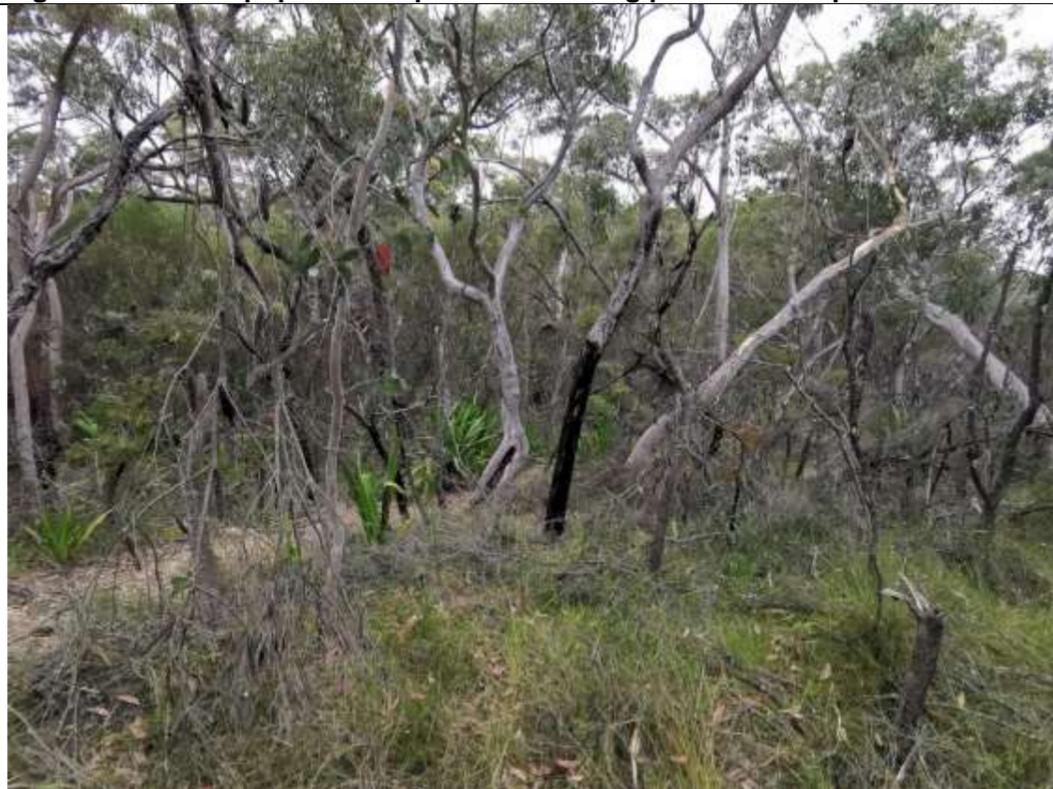
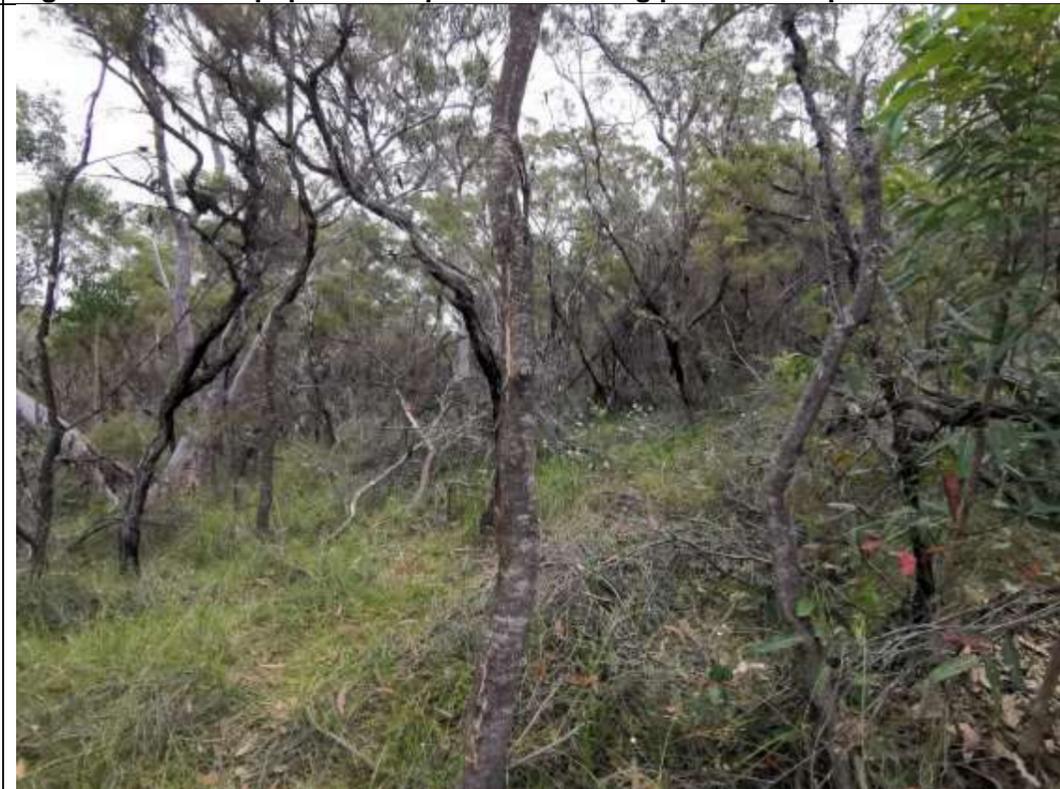
Ongoing erosion of the track through subpopulation 4 was observed, as was in previous years. This is attributable to poor track maintenance and natural surface flows not attributable to the project. No noticeable NPWS maintenance of this track within the Brisbane Water National Park has occurred since the commencement of monitoring.

Dieback and decomposition of the *Banksia ericifolia* was evident particularly for Sub-population 4. Vigorous regrowth of a dense healthy shrub cover was observed at sub-population 3. The following estimates of the vegetation density for both sub-populations are provided:

Figure 2.3a – Sub-population 4 photo monitoring point north aspect

Figure 2.3b – Sub-population 4 photo monitoring point east aspect

Figure 2.3c – Sub-population 4 photo monitoring point south aspect

Figure 2.3d – Sub-population 4 photo monitoring point west aspect

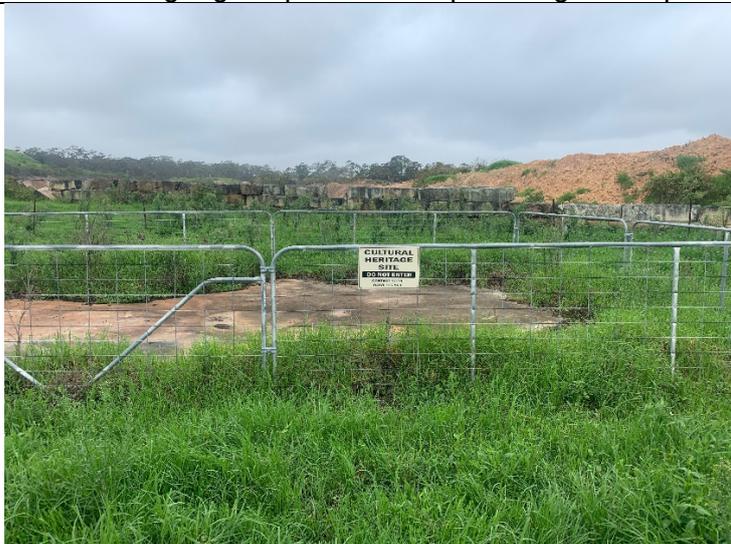
Plate 1 The inner perimeter fence 2019

As per the inspection, post approval, undertaken by Insite Heritage Pty Ltd, in 2015, the sandstone block wall, 8m perimeter fencing and signage have remained in-situ throughout 2019. These mitigation measures were undertaken as per the CHMP and Statement of Commitments.

Plate 1 – a recent photograph shows the fencing, sandstone block wall, inner barrier and signage in place and is providing the required protection.

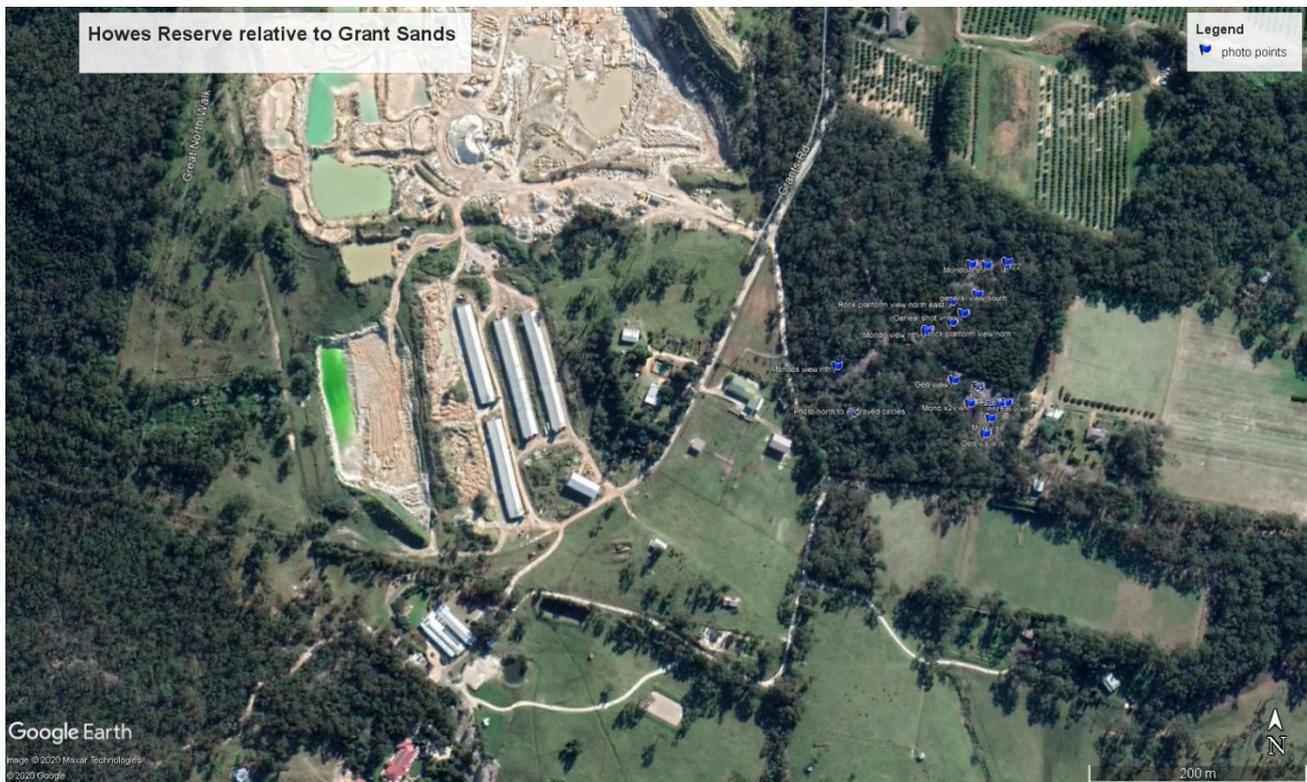
The monitoring of Howes Reserve in conjunction with the Grants Sand site was undertaken as per the CHMP requirement. A visual inspection was undertaken in three main areas – the main area of engravings to the south east, the exposed for sheet to the south west including the vertical engraving on the rock shelf face, and the rock shelf to the north side of Howes Reserve.

Figure 1 Grant Sands relative to Howes Reserve - Photographic points across Howes Reserve in blue

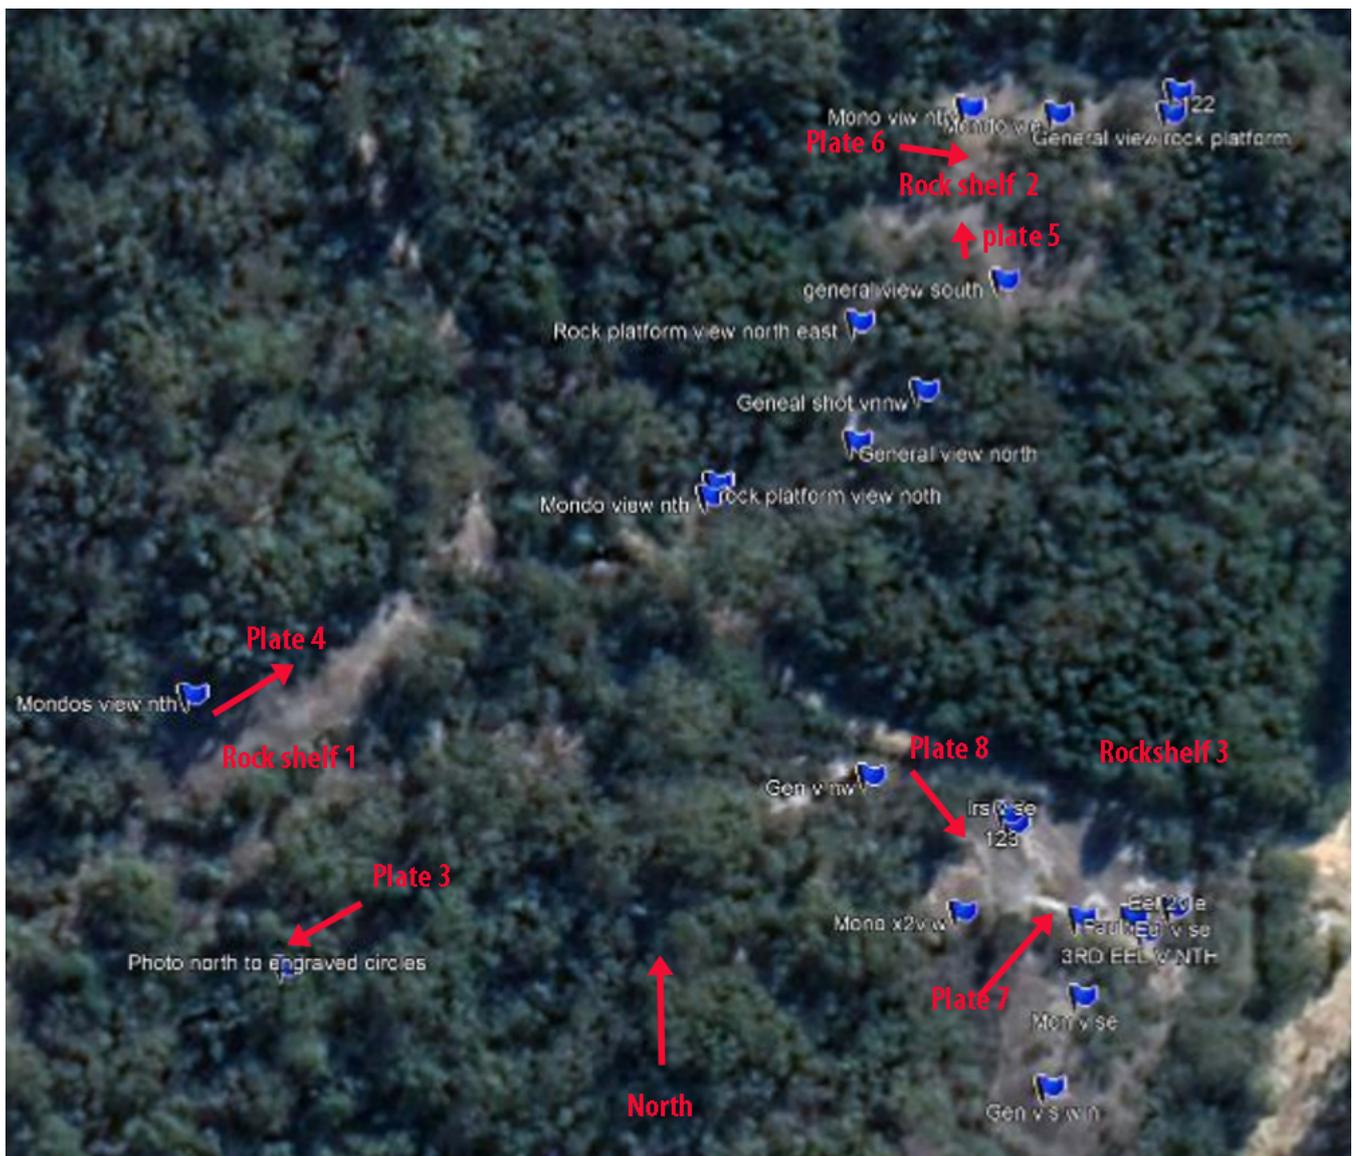
Figure 2 Howes Reserve photographic locations in table below

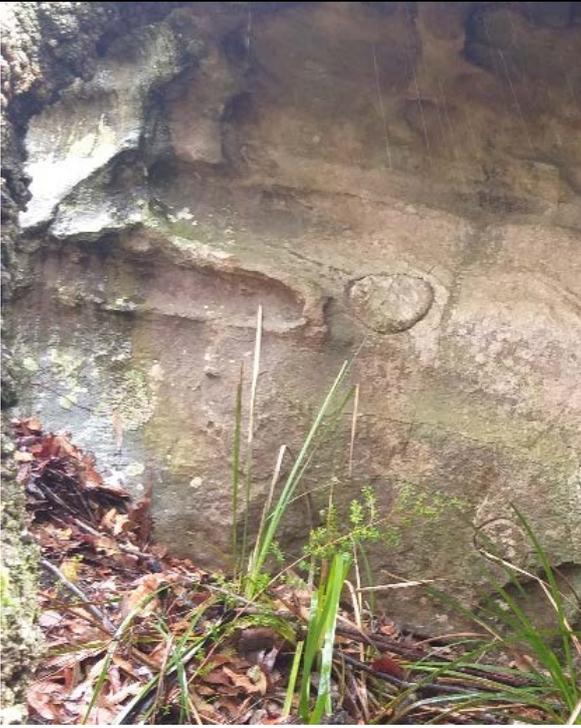
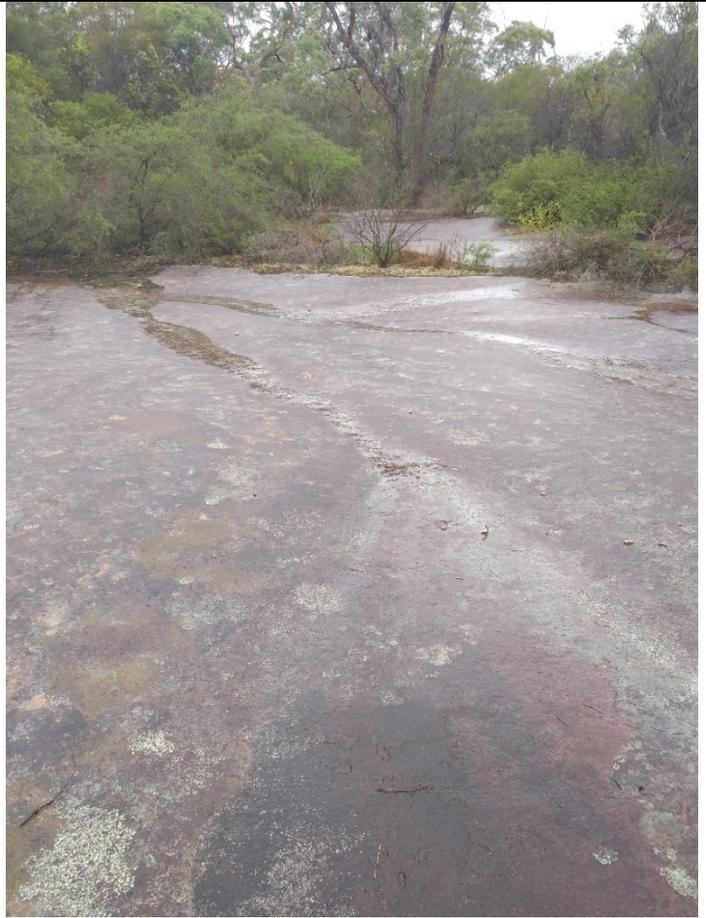
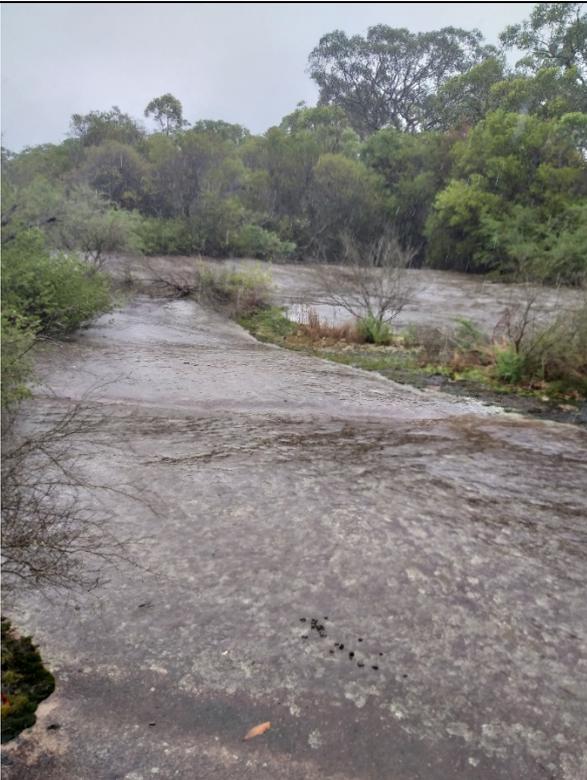
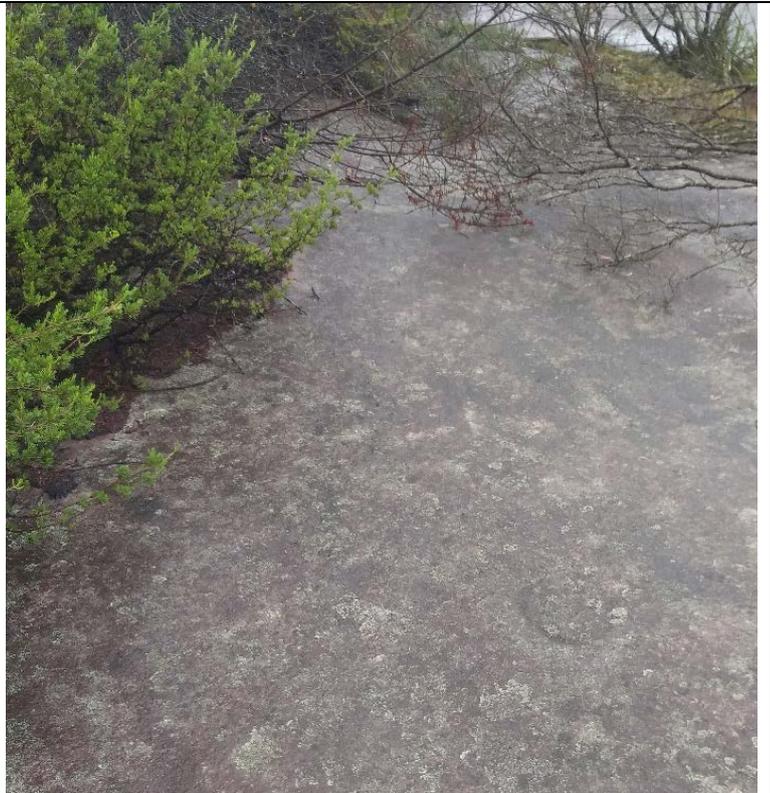
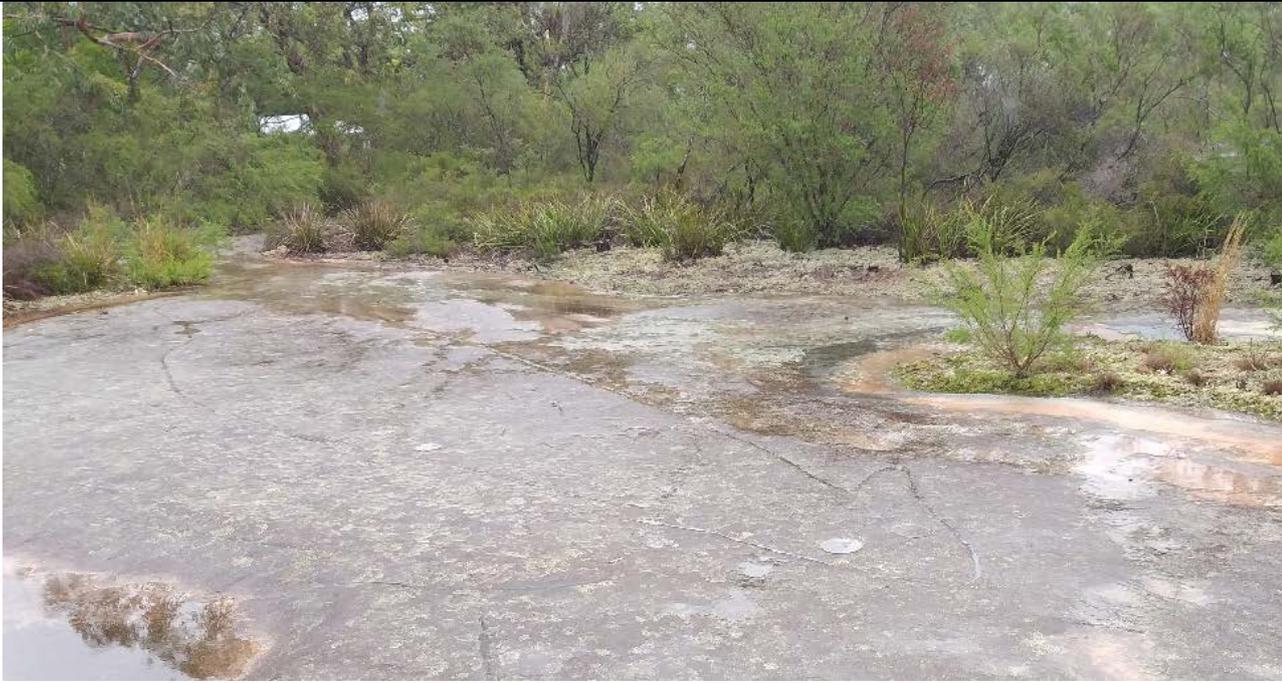
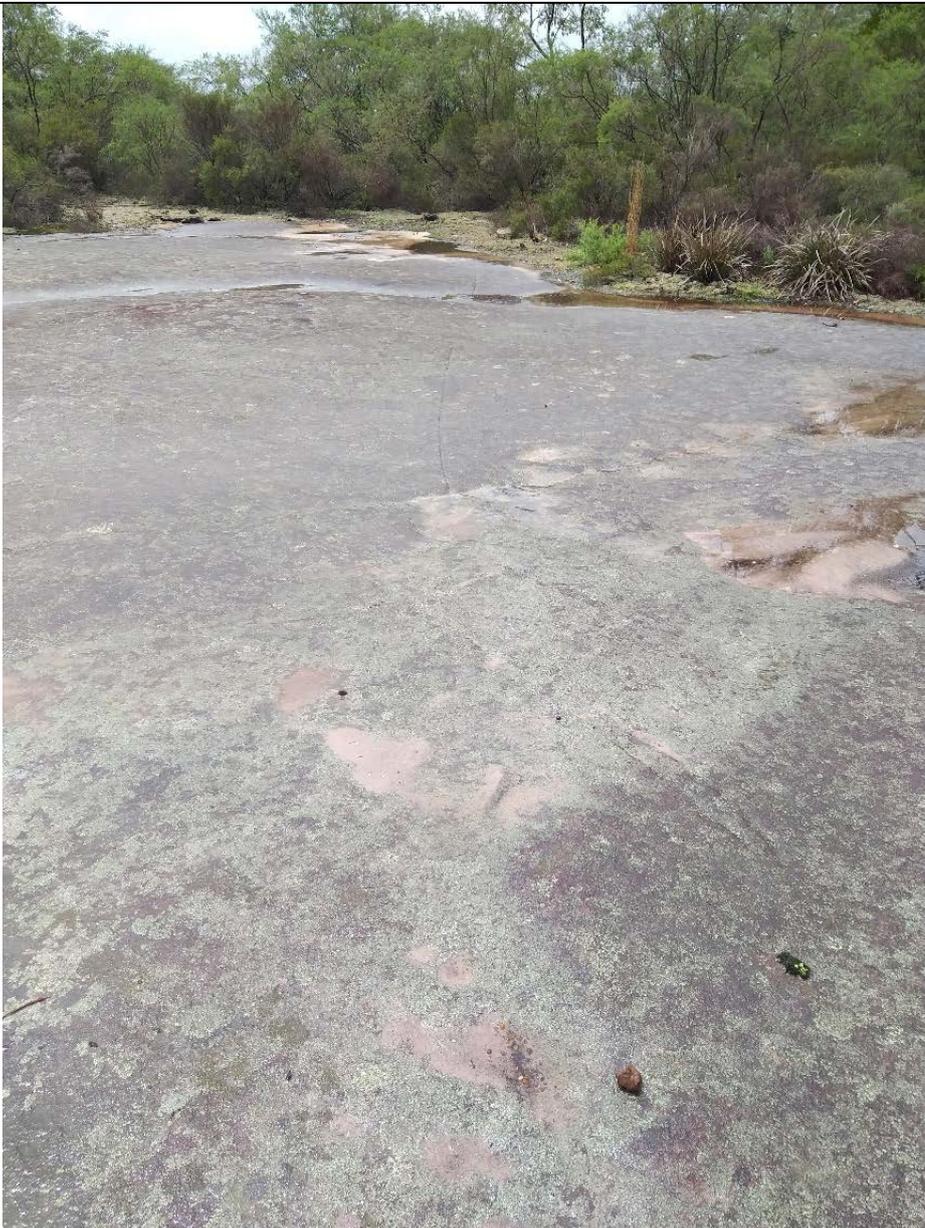
Plate 3 Engraving on vertical face

Plate 4 View south east across rock platform above previous plate

Plate 5 View north east over rockshelf 2

Plate 6 a Mondo (circular engraving) Rockshel 2

Plate 7 Eel engraving (one of 3 eels side by side) view south east Rockshelf 3

Plate 8 View south over rockshelf 3 east. fainter engraving in foreground

The inspection of Howes Reserve did not find any evidence, such as rockshelf cracking, displacement or scouring due to dust deposition. At the time of inspection it had rained, and it is evident that natural sheet erosion of the sandstone rock shelves and wash from the access road through the reserve, have produced some sand that washes over the lower lying sites.
