Appendix 3
NOISE AUDIT FEBRUARY 2017
Atkins Acoustic

Grants Road Sand Pty Ltd.
Grants Road
SOMERSBY NSW 2250

ENVIRONMENTAL NOISE AUDIT
GRANTS ROAD SAND QUARRY
SOMERSBY

THIRD ANNUAL MONITORING REPORT

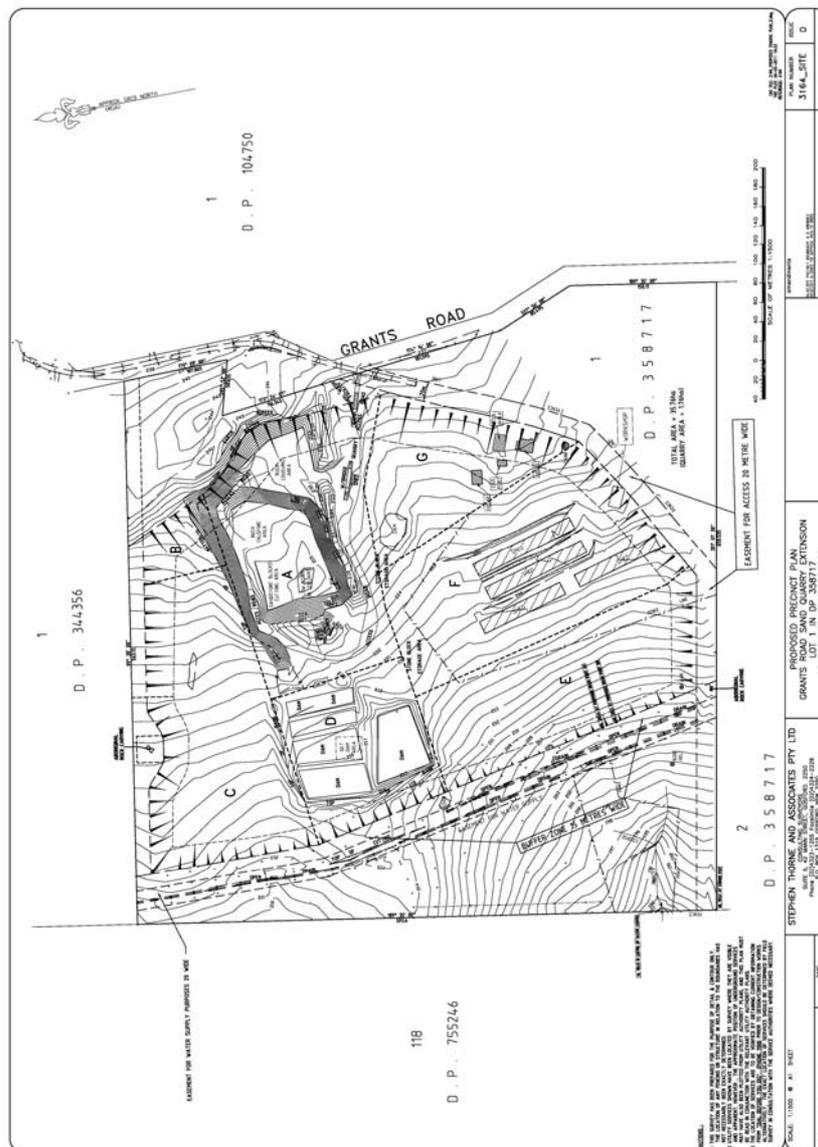
Figure 1. Quarry Precinct Layout

The audit identified onsite extraction and processing of quarry products on Areas A and B (*Figure 1*). Operating plant and equipment identified during the audit included:

- McClosky (Tricon) Screen and loader in centre portion of Area B.
- Truck loading from stockpile area south-western portion Area A.
- Saw cutting central lower portion of Area A.

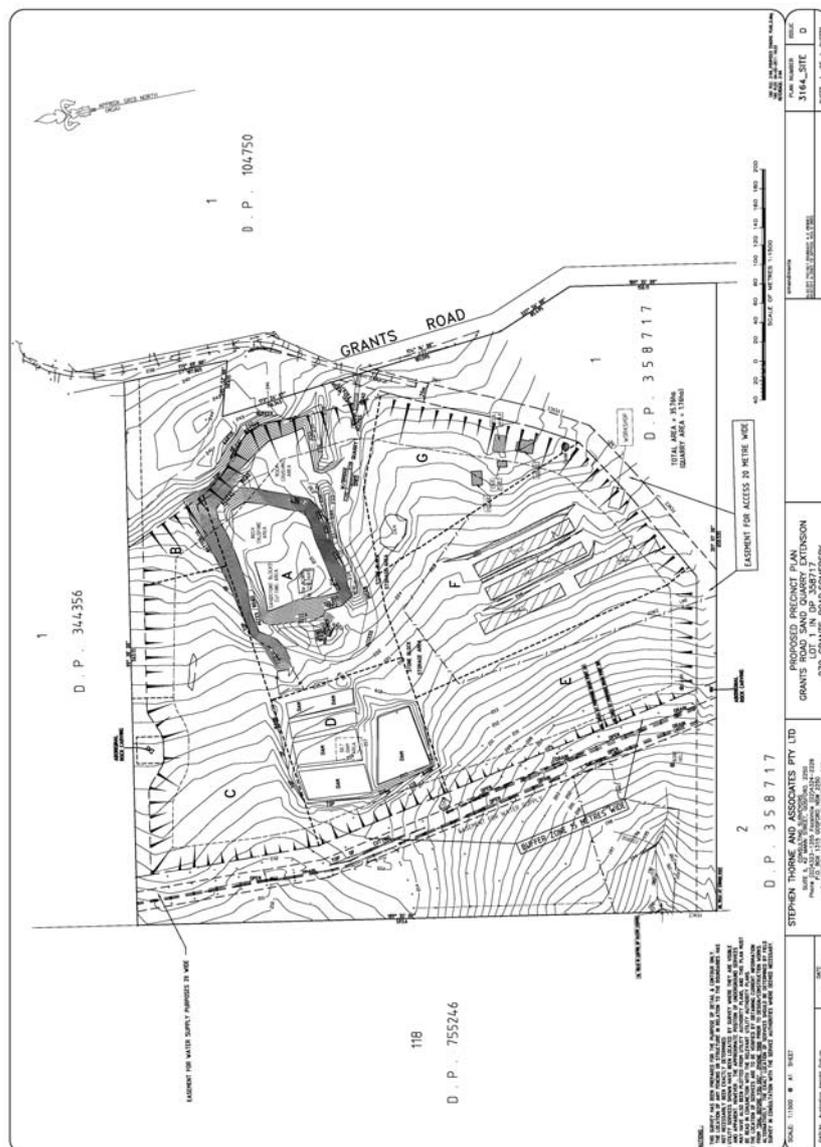
Figure 1. Quarry Precinct Layout

- McClosky (Tricon) Screen and loader in centre portion of Area B.
- Truck loading from stockpile area south-western portion Area A.
- Saw cutting central lower portion of Area A,
- Water pump and washing plant

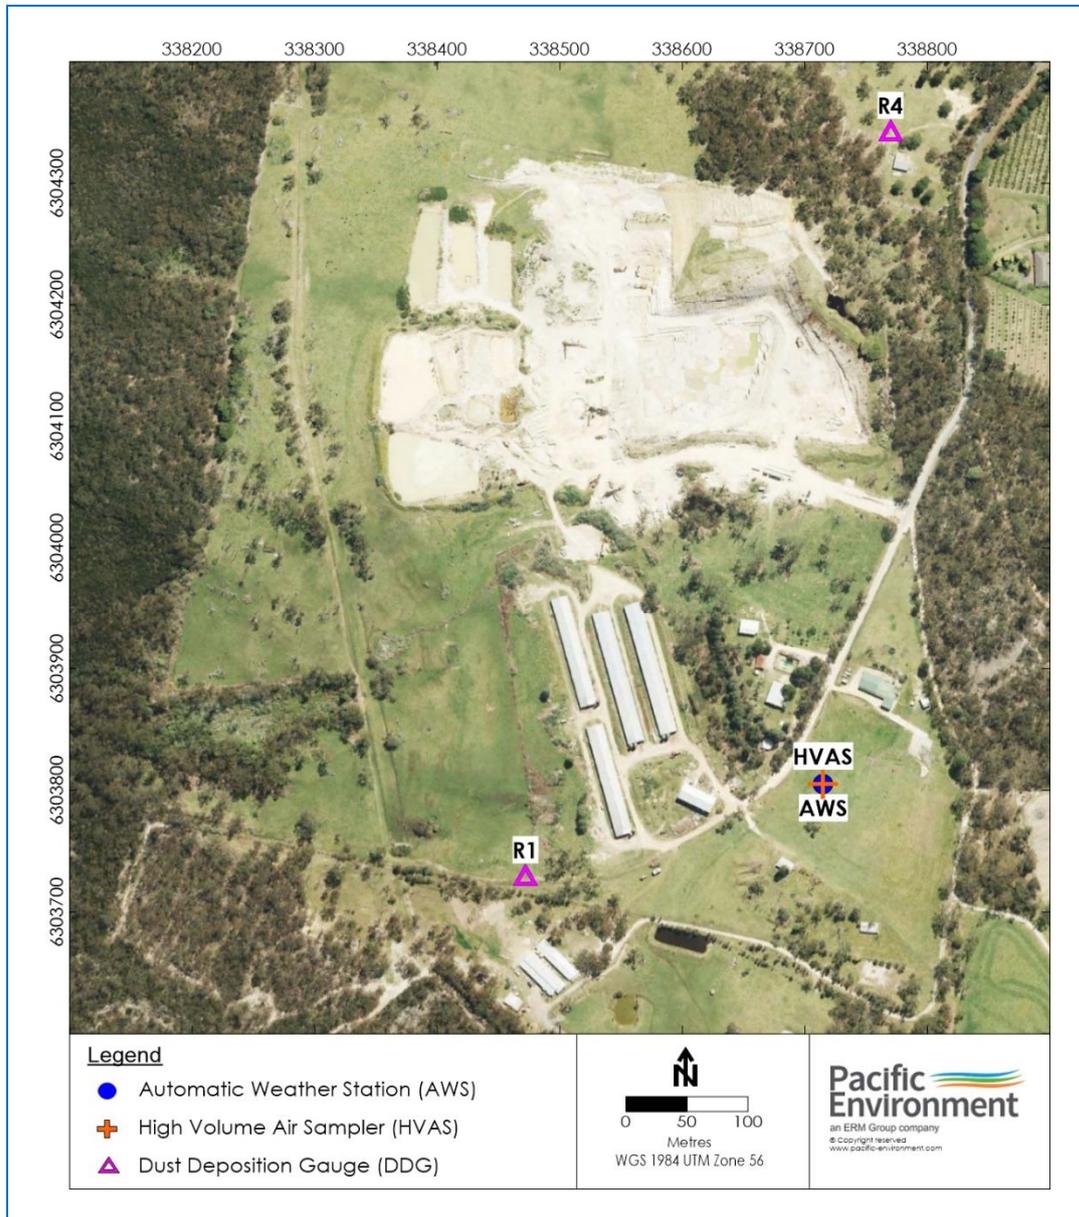
Figure 3-1: Monitoring Locations at Grants Rd. Quarry

The Grants Road Sand Quarry baseline monitoring locations are shown in Figure 3-1. Featured are the automatic weather station (AWS), the High Volume Air Sampler (HVAS) and two dust deposition gauges (R1 and R4).

Dust deposition is measured at two locations, R1 and R4, as shown in Figure 3-1. The results for the available dust deposition data are presented in Figure 4-5. Of a possible 12 samples, 12 samples are reported. The average dust deposition level over the recorded period was 0.6 g/m²/month at R1 and 0.9 g/m²/month at R4, which are well below the EPA cumulative annual average criterion of 4 µg/m³. The maximum level of 4 g/m²/month was recorded in February at R4 but all other recorded levels were below 2 g/m²/month.

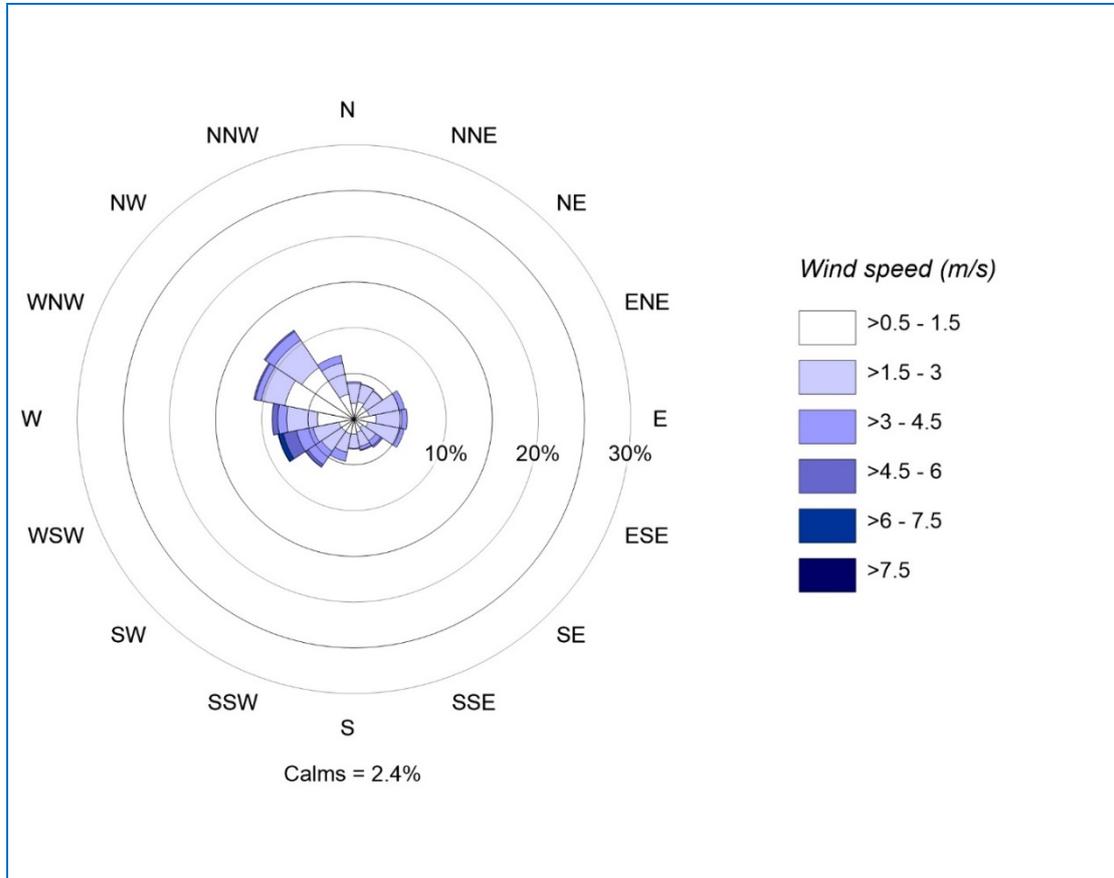
Figure 4-1: Grants Road Sand Wind Rose, 2017

A wind rose for the annual period 2017 is presented in Figure 4-1. The wind rose indicates that winds from the west are dominant. The average wind speed for the period was 1.9 m/s and the percentage occurrence of calm wind conditions (less than or equal to 0.5 m/s) was 2.4 %.

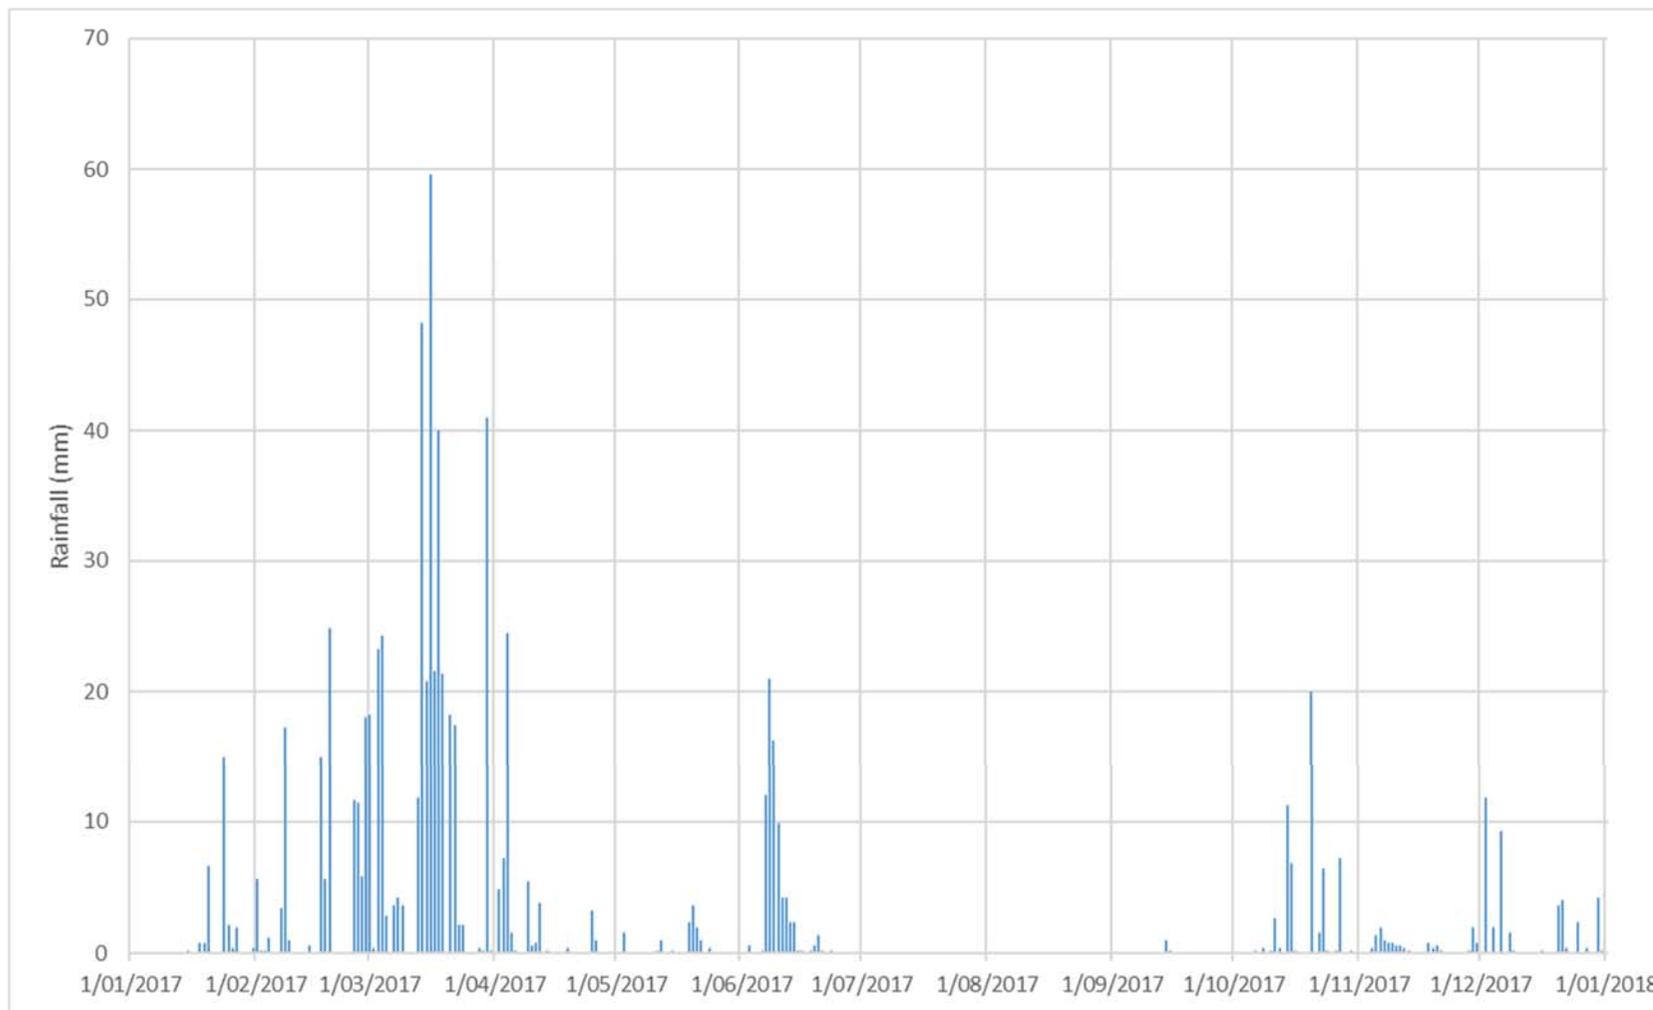
Figure 4-3: Daily Rainfall, 2017

A plot of the daily average rainfall is shown in Figure 4-3 and the monthly average rainfall is shown in Figure 4-4. March recorded the highest monthly rainfall of 385 mm.

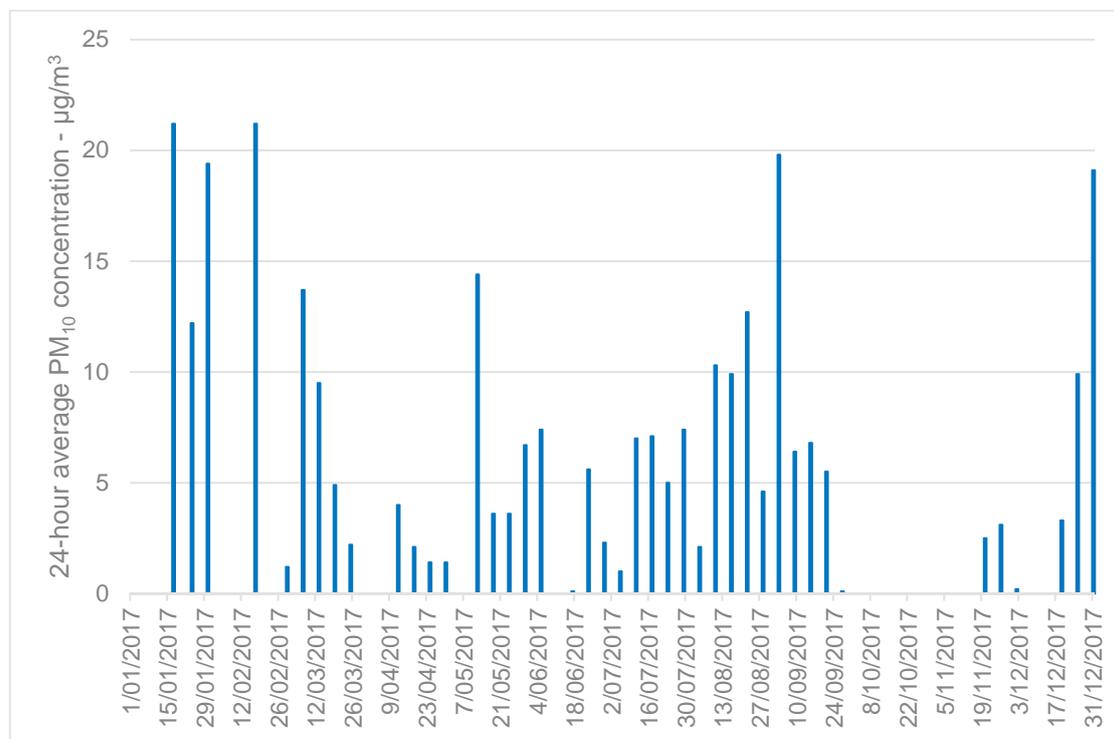
Figure 4-5: HVAS Monitoring Results for PM₁₀, 2017

The results for the available PM₁₀ data are presented in Figure 4-5. Of a possible 60 samples (over approximately 12 months), thirty eight samples are reported, resulting in a data recovery rate of approximately 71%. The average PM₁₀ concentration over the recorded 1-year period was 6.8 µg/m³, which is well below the annual EPA impact assessment criterion of 25 µg/m³. All reported results are well within the EPA maximum 24-hour average criterion of 50 µg/m³ for PM₁₀, with a maximum 24-hour average of 21.2 µg/m³ recorded on 17 February 2017.

The dust sample collected by the HVAS monitor includes both dust generated by site activities (incremental dust impact) and dust from all other local sources (background dust levels). However as stated previously, even with the background levels accounted for, the PM₁₀ levels are considerably below their respective 24-hour and annual criterion.

Given the results of the data during the monitoring period, currently no action is required to control environmental performance. Rather it is recommended that current mitigation processes are sustained.

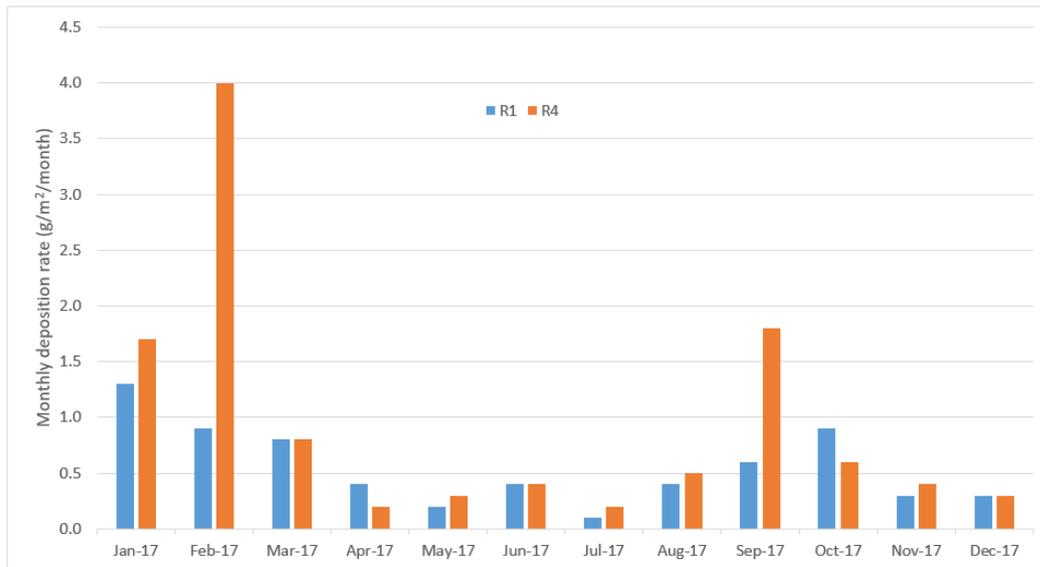
Figure 4-6: Dust deposition monitoring results for 2017

The dust sample collected by the deposition gauges includes both dust generated by site activities (incremental dust impact) and dust from all other local sources (background dust levels). Even with the background levels accounted for, the deposition levels are considerably below both the incremental and cumulative annual criteria.

Given the results of the data during the monitoring period, currently no action is required to control environmental performance. Rather it is recommended that current mitigation processes are sustained.

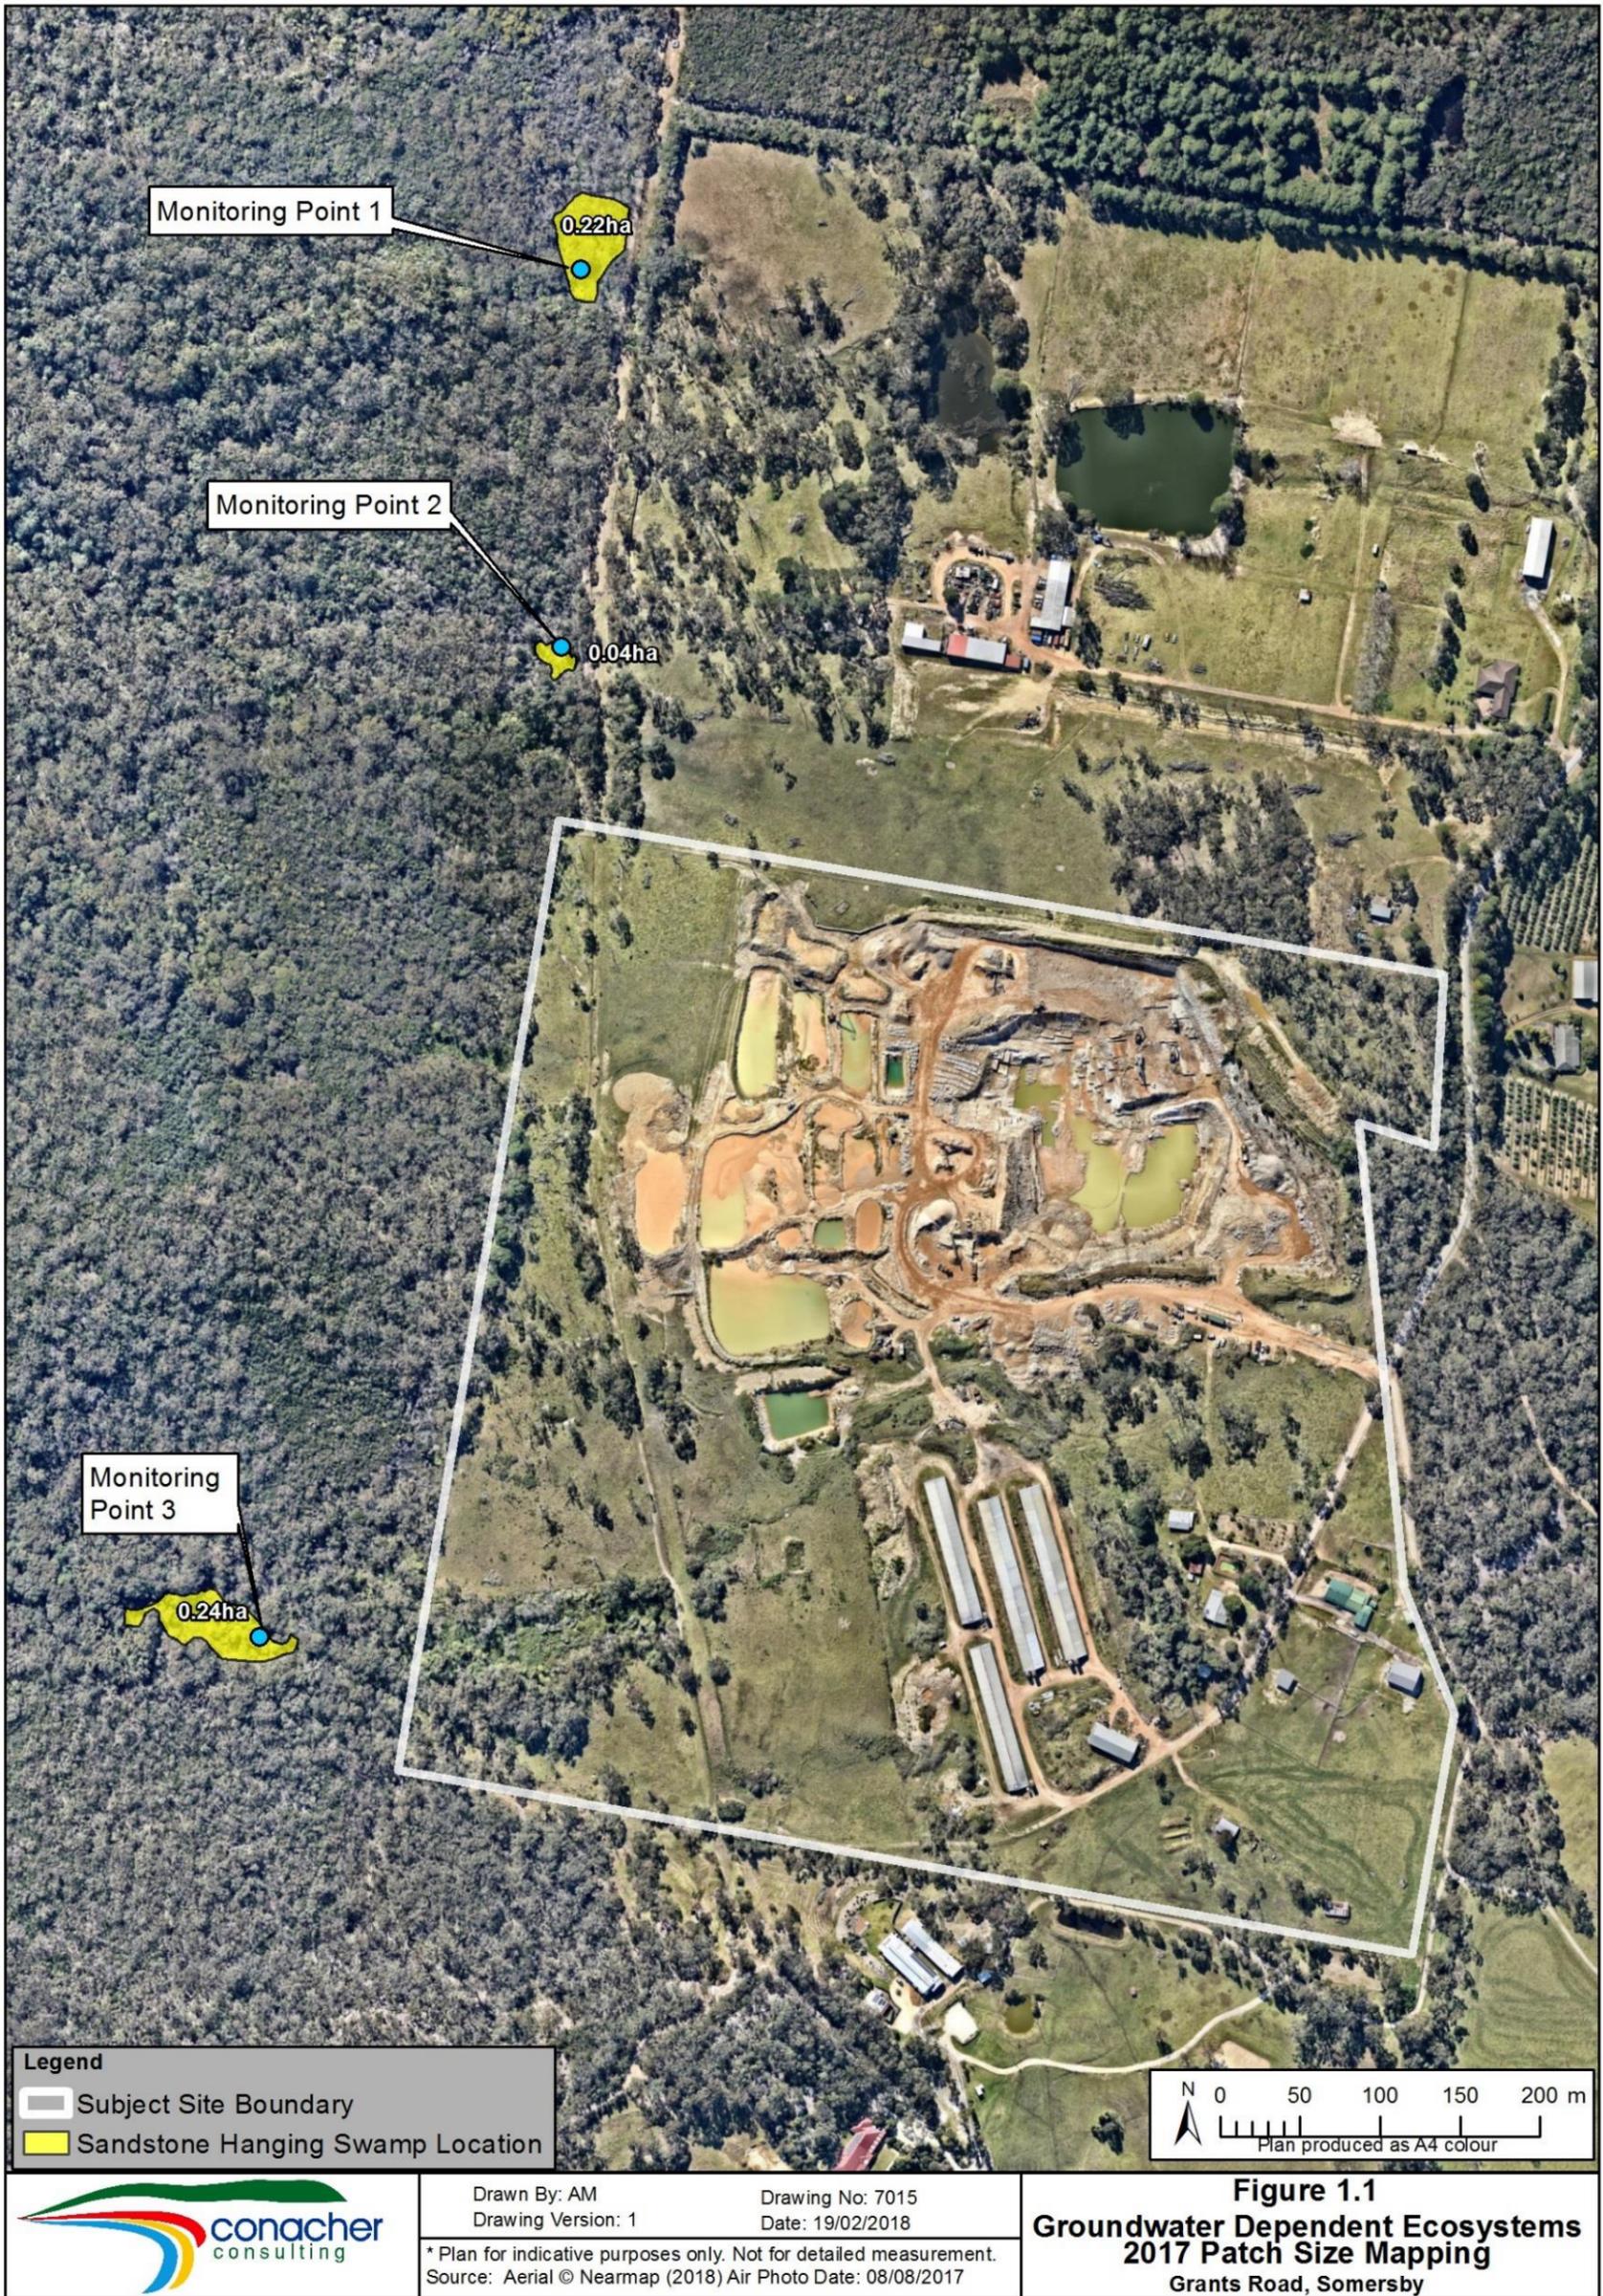
Three monitoring quadrats were surveyed at each of the locations shown in Figure 1.1. Groundwater dependant ecosystem condition was monitored through sampling of both qualitative and quantitative variables. The following variables were measured:

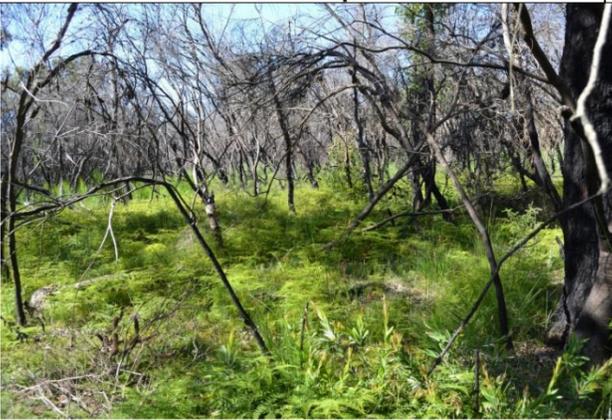
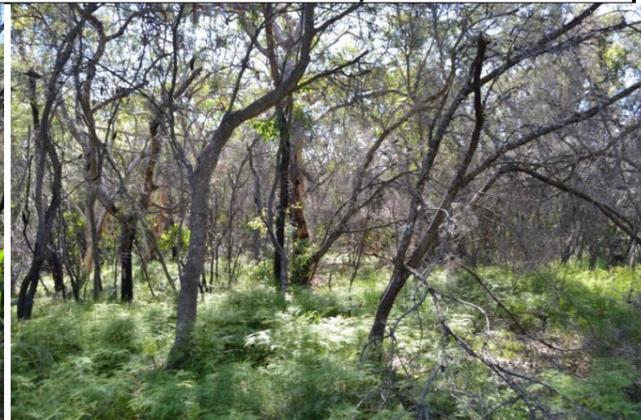
Northern Aspect	Eastern Aspect	Southern Aspect	Western Aspect
MQ1 2016

**TABLE 2.3
GROUNDWATER DEPENDANT ECOSYSTEM COMPARITIVE QUADRAT MONITORING PHOTOGRAPHS**

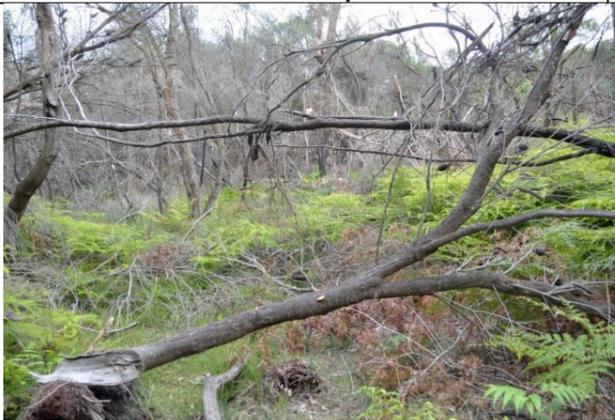
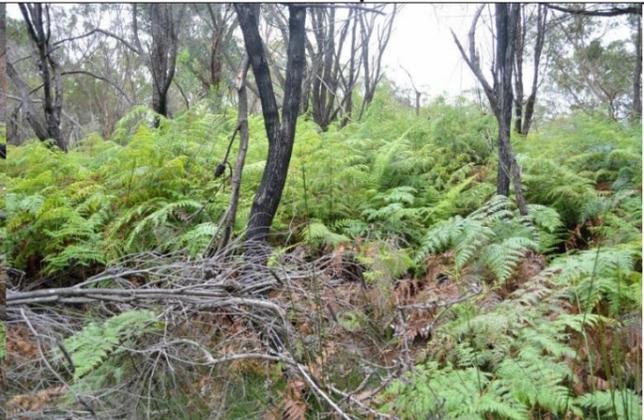
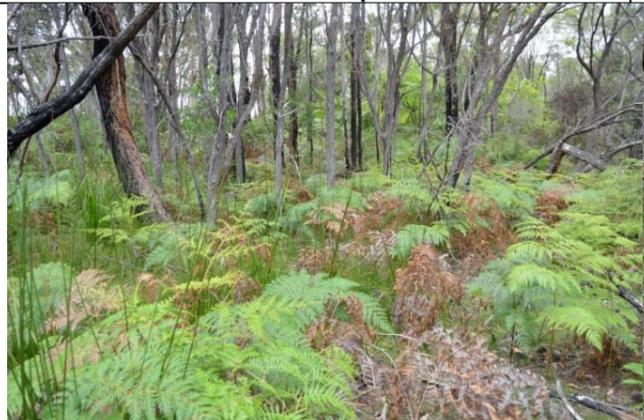
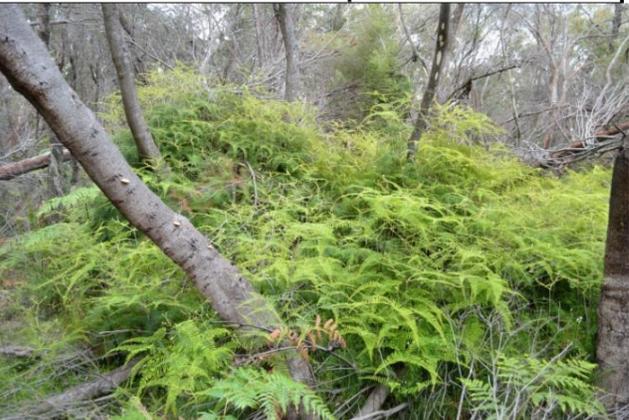
Northern Aspect	Eastern Aspect	Southern Aspect	Western Aspect
MQ2 2017

**TABLE 2.3
GROUNDWATER DEPENDANT ECOSYSTEM COMPARITIVE QUADRAT MONITORING PHOTOGRAPHS**

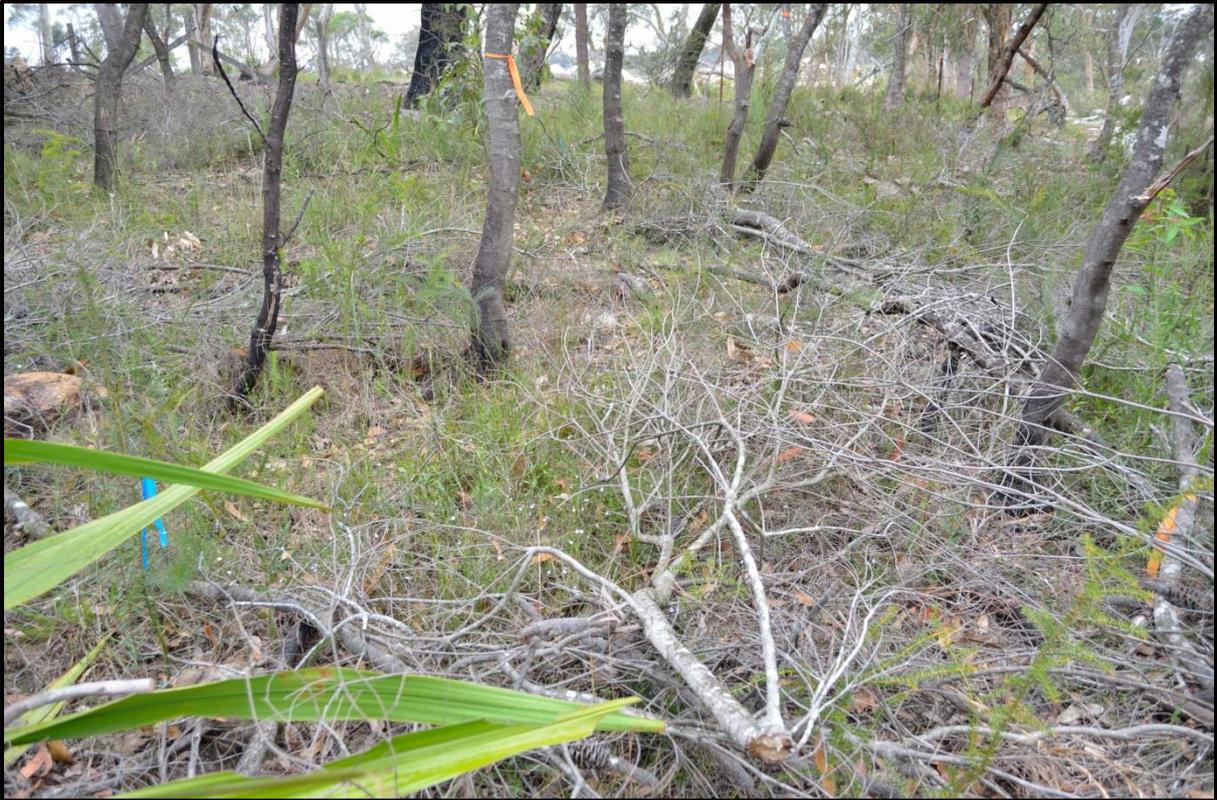
Figure 2.2 Photo Point 1 Sub-population 3 habitat in November 2017

No visible signs of disturbance to *P. junonis* or its habitats as a result of quarry activities were observed. Photographs of the habitats at subpopulations 3 and 4 during the 2017 monitoring period are provided in Figures 2.2 to 2.4. Erosion of the track through subpopulation 4 was observed in previous years. No noticeable NPWS maintenance of this track within the Brisbane Water National Park has occurred since the commencement of monitoring.

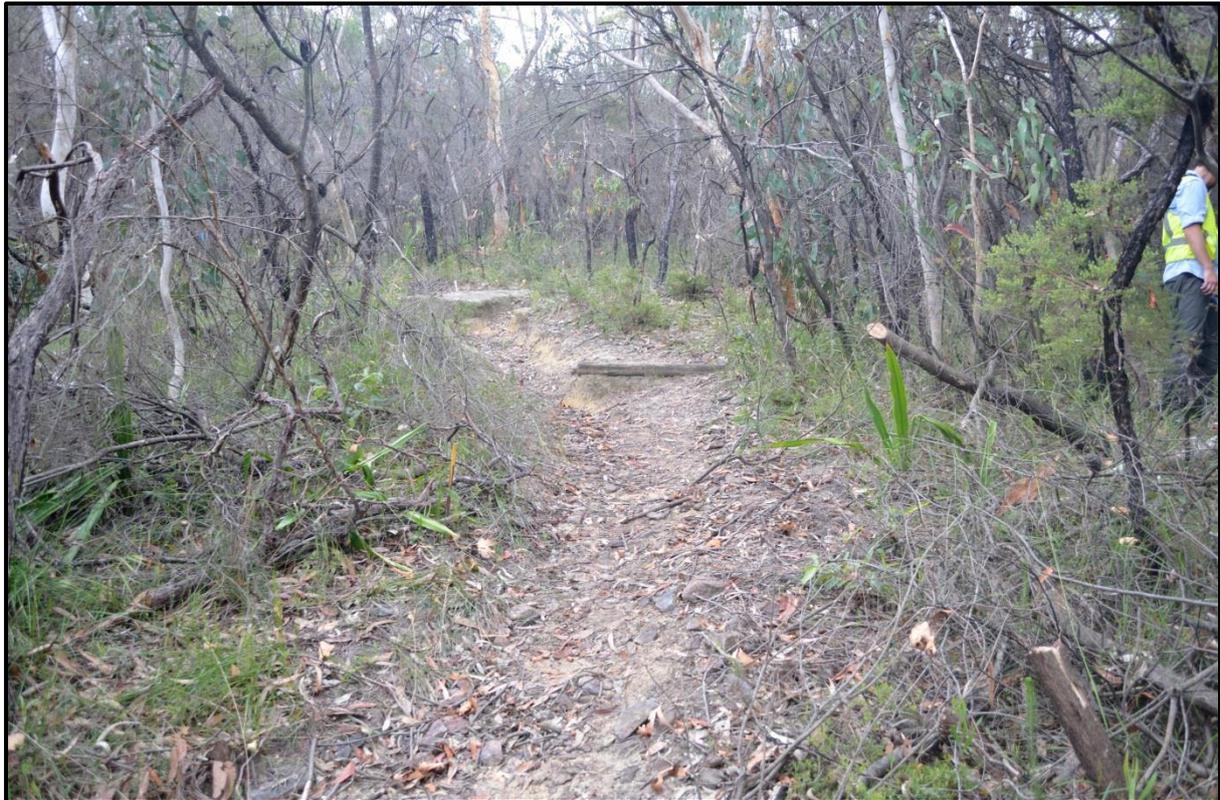
Figure 2.4. Photo of erosion of track through Sub-population 4 in November 2017

The previous location of *P. junonis* identified along the Great North Walk track showed noticeable signs of erosion caused by inadequate track maintenance and poor design.

- i. Further counts of the previously identified locations of *P. junonis* should be undertaken during the 2018 monitoring period.
- ii. Suitable erosion and sedimentation controls should continue to be maintained for the site.
- iii. The plants and associated habitats present are continuing to regenerate following the 2015 hazard reduction burning operations of the NPWS.
