## Road Condition Assessment and Road Contributions Study

270 Grants Road, Somersby

June 2015  
Our Ref: SY140135

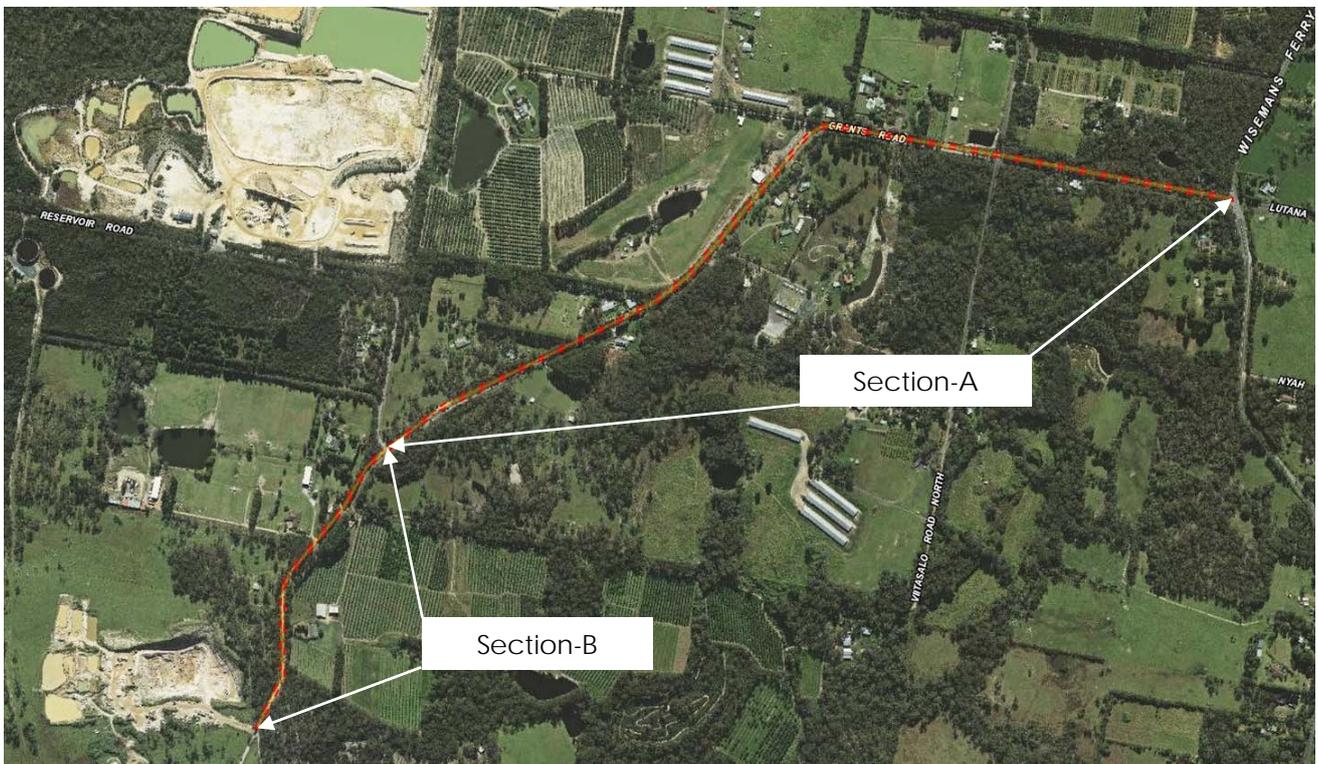
Figure 2 Site Location showing Section-A and Section-B

- Section-A, this section is loaded by both Hansons Central Coast Sands Quarry and the Grants Road Sand Quarry. This is the section from Wisemans Ferry Road to the intersection of Reservoir Road, from which Hanson trucks exit. This section is 1,940m long.
- Section-B, this section is loaded by Grants Road Sand Quarry but not the Hanson Central Coast Sands Quarry. This is the section between Reservoir Road and Grants Road Sand Quarry. This section is 660m long.
